Appendix E – Tree Inventory and Evaluation

August 22, 2021

RE: 620 Airport Blvd., Burlingame- Tree Inventory and Evaluation

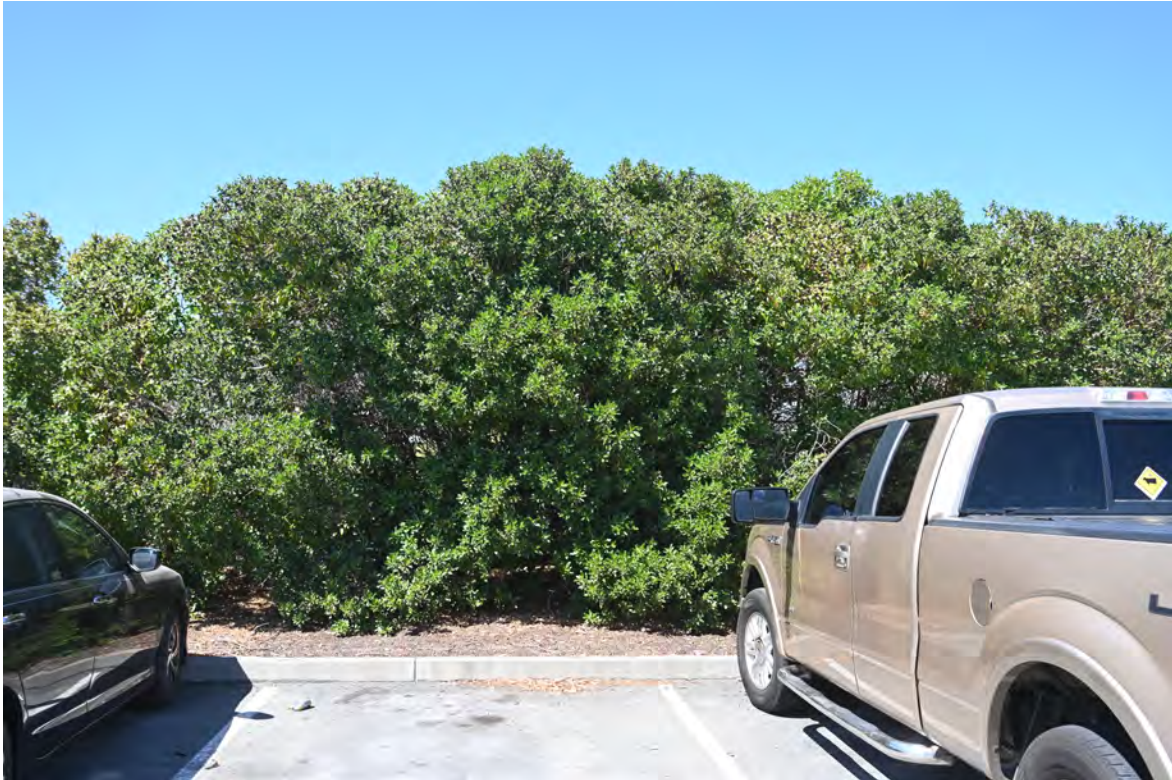
Part of the massing of myoporum shrubs in the northwest corner of the parking lot within the proposed project limits.

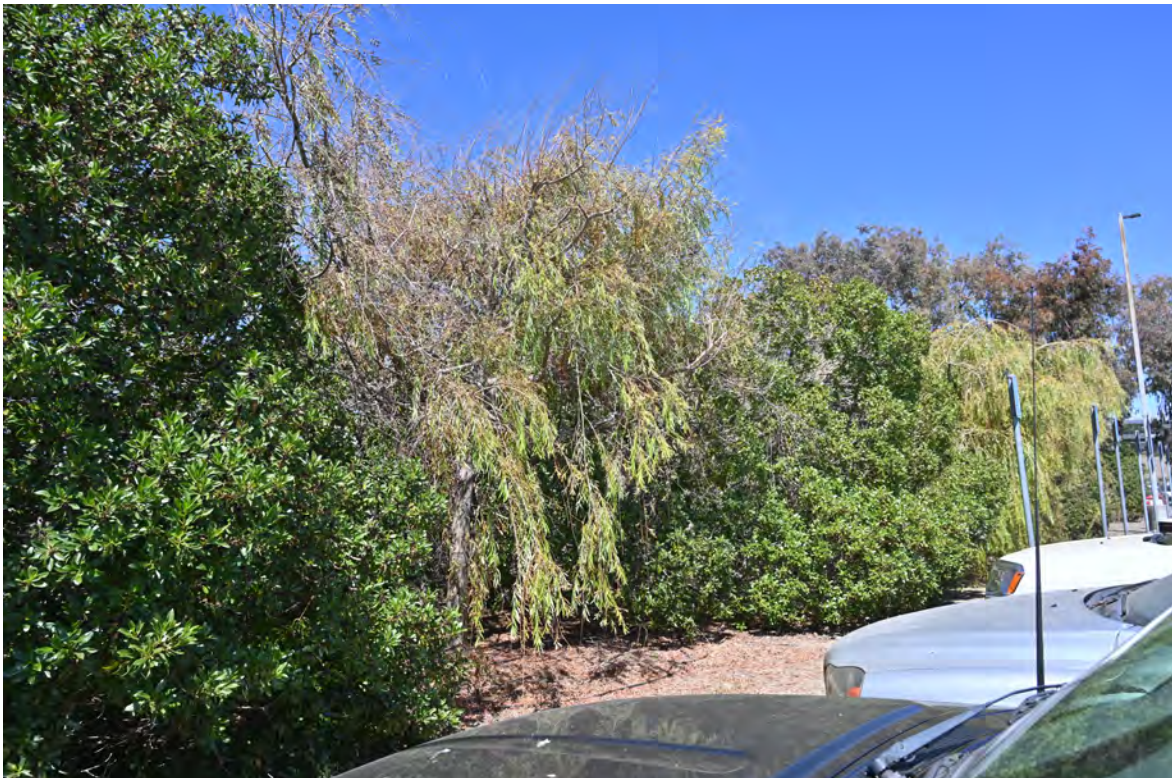
Tree #1, a weeping willow located within the project limits.

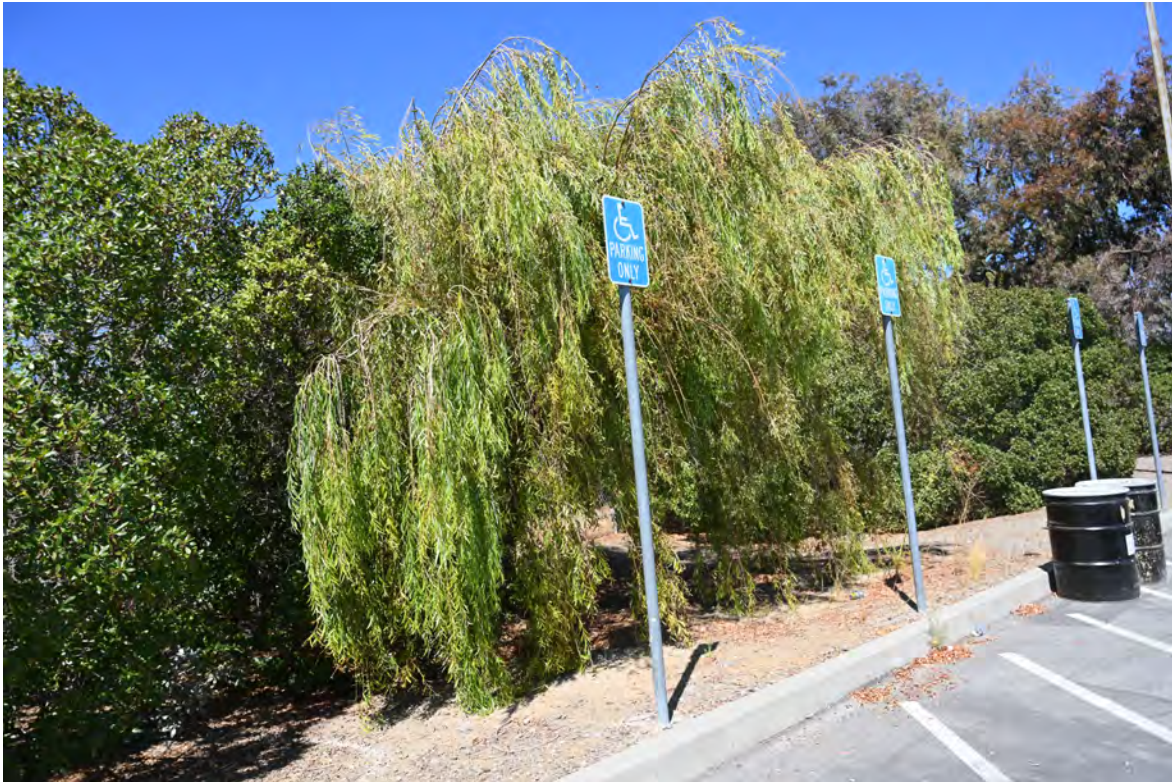
Tree #2, a weeping willow located within the project limits.

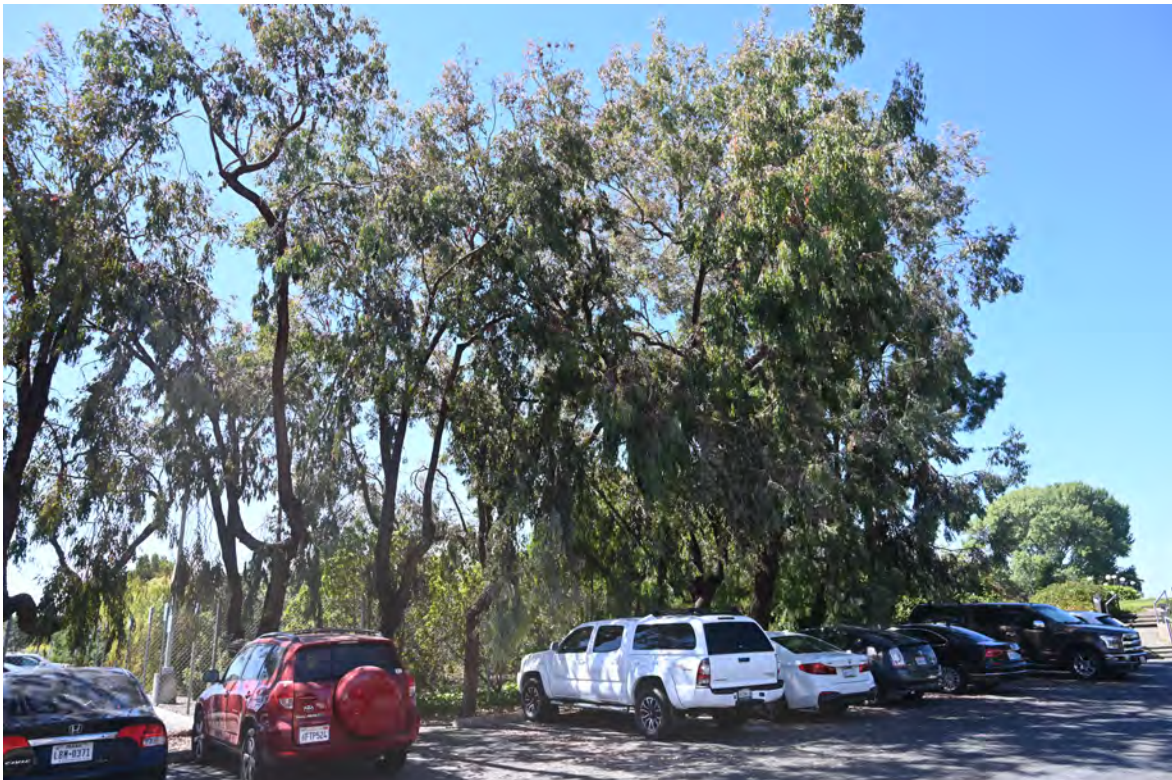
The north section of the eucalyptus row including four trees that extend beyond the project fence corner (trees #3-#6).

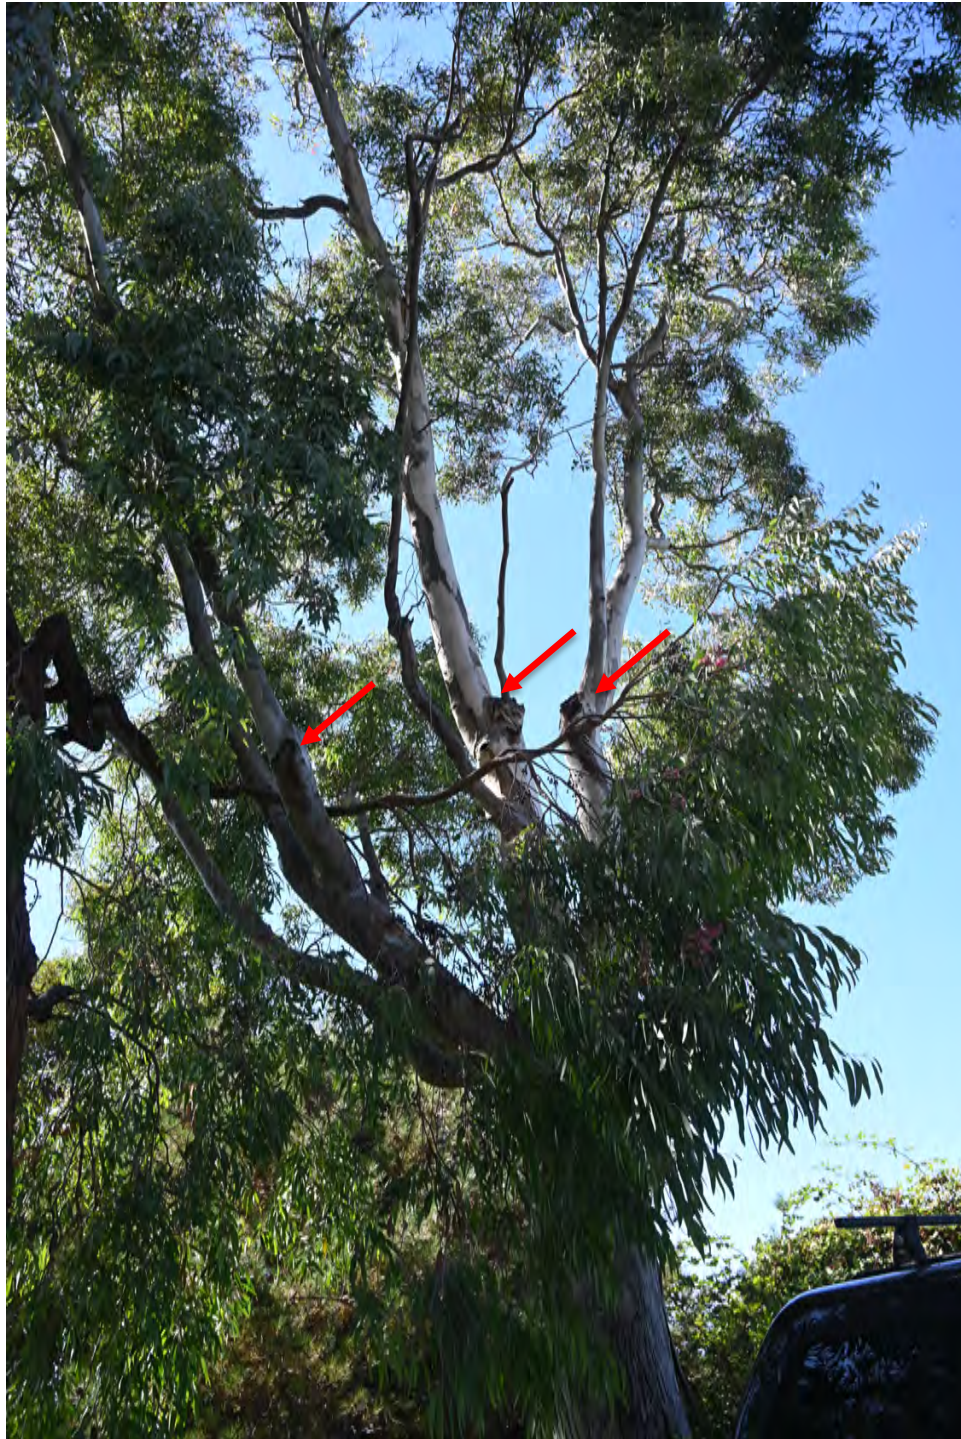
Tree #3, a red flowering yellow gum with arrows indicating old topping cut locations.

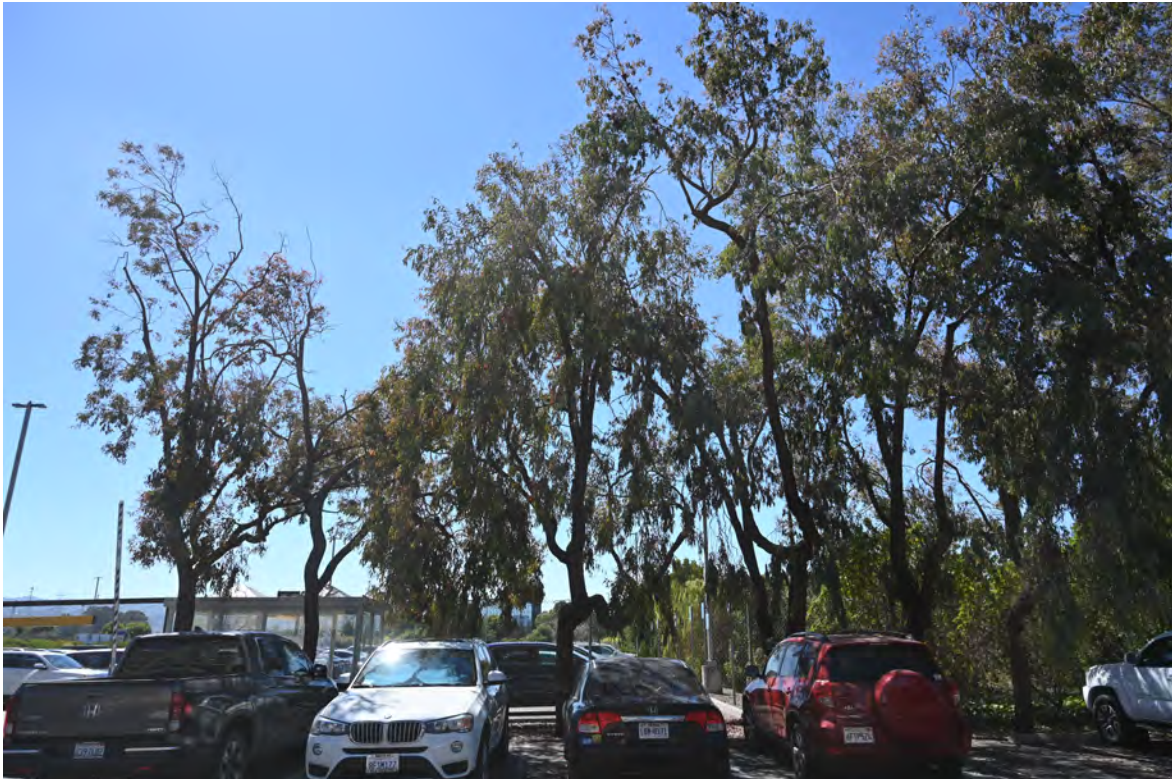
A portion of the row of pink ironbark. Note the irregular and contorted limb structures. The two trees on the left are in poor health with branch and limb dieback.

17	pink ironbark	8	1	30'-45'±	20'-30'±	10'	1.5	2.0	Significant limb and branch dieback occurring.	No	Poor
18	pink ironbark	9	1	30'-45'±	20'-30'±	1'	1.5	2.0	Significant limb and branch dieback occurring.	No	Poor
19	pink ironbark	9	1	30'-45'±	20'-30'±	0'	2.5	2.0	See above description (tree #4).	No	Poor to Fair
20	pink ironbark	9.5	1	30'-45'±	20'-30'±	6'	2.5	2.0	See above description (tree #4).	No	Poor to Fair
21	pink ironbark	10.5	1	30'-45'±	20'-30'±	13'	2.5	2.0	See above description (tree #4).	No	Poor to Fair
22	pink ironbark	12	1	30'-45'±	20'-30'±	9'	2.5	2.0	See above description (tree #4).	No	Poor to Fair
23	pink ironbark	11	1	30'-45'±	20'-30'±	5'	2.5	2.0	See above description (tree #4).	No	Poor to Fair

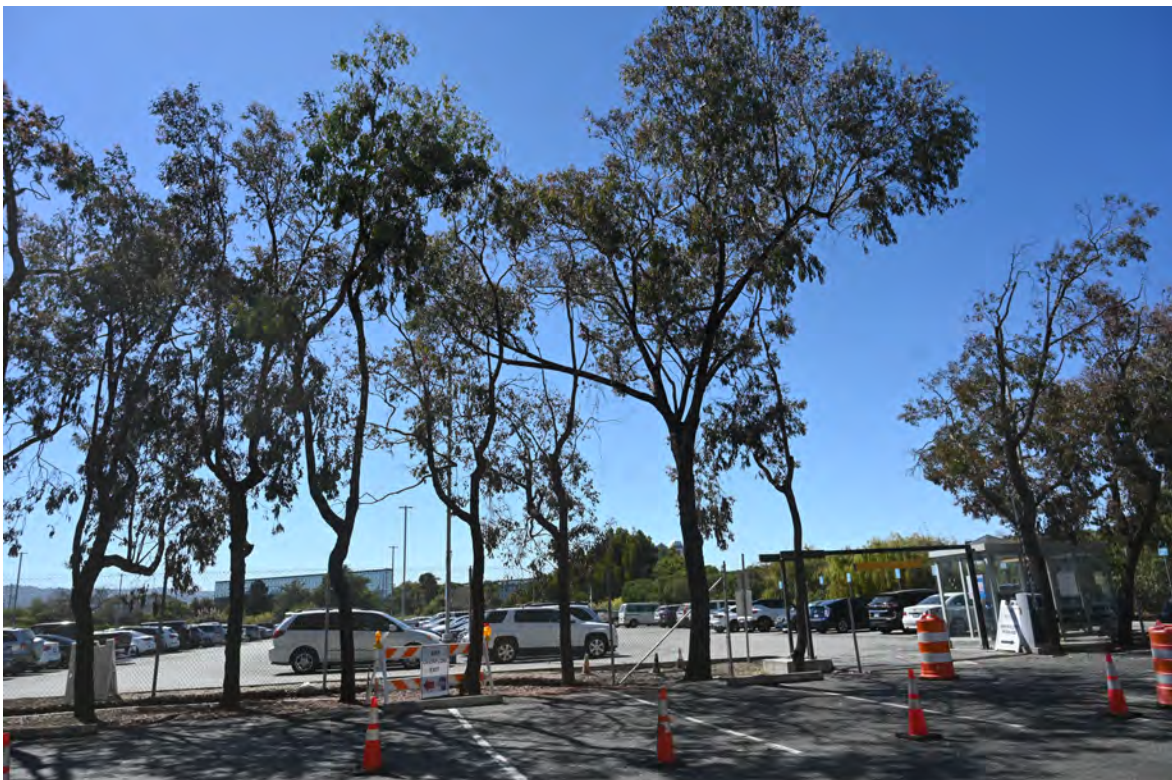
The southern portion of the row of the pink ironbarks.

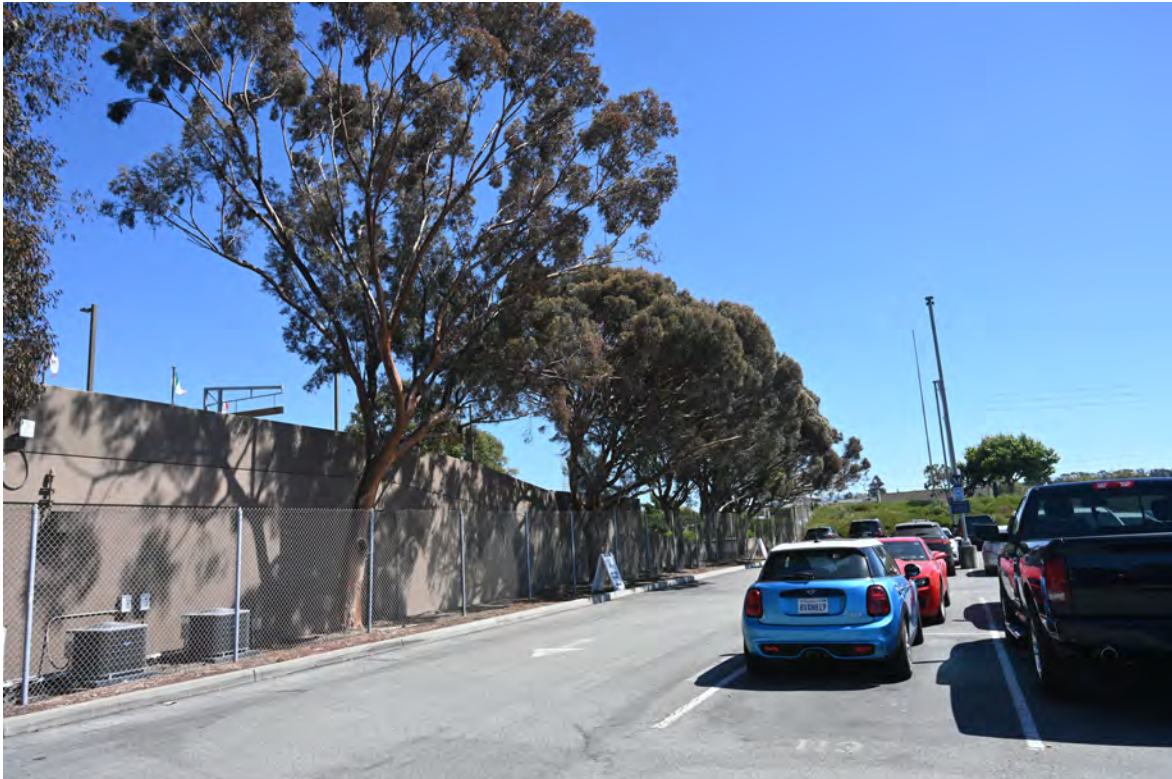
The white peppermint gums are located adjacent to the fence line, with the crowns extending over the proposed project limits.

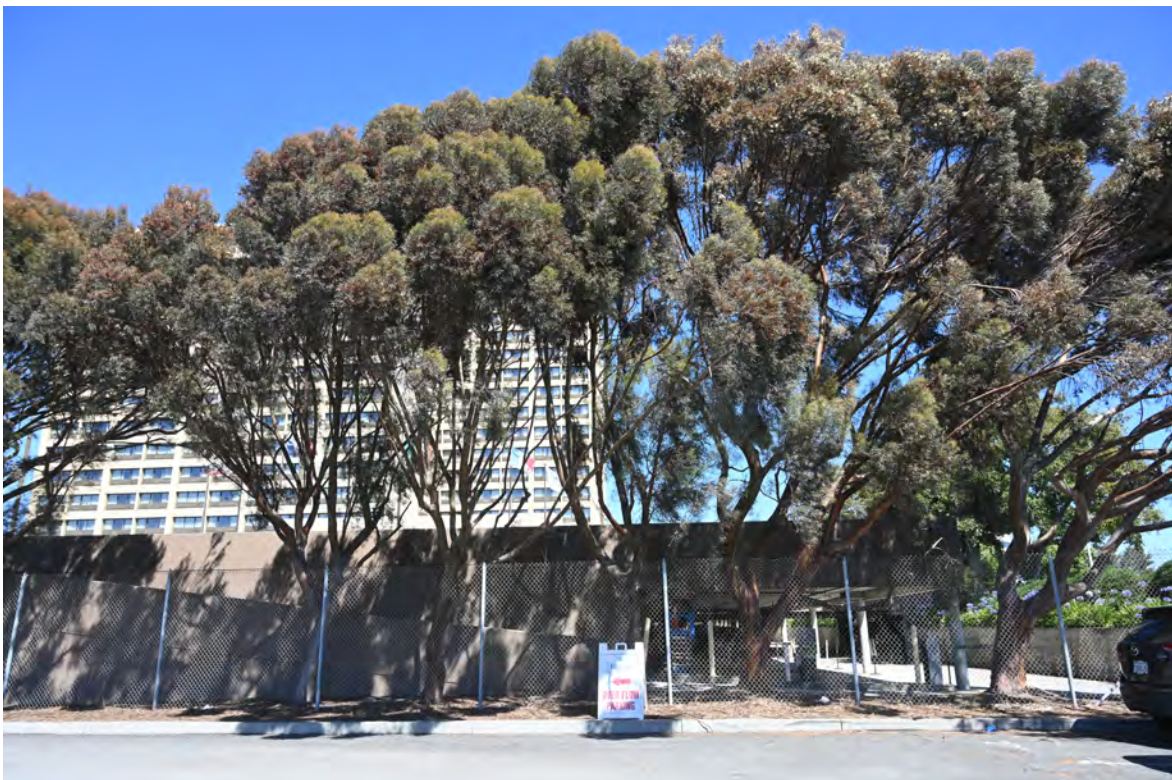
The row of white peppermint gums is next to the parking structure.

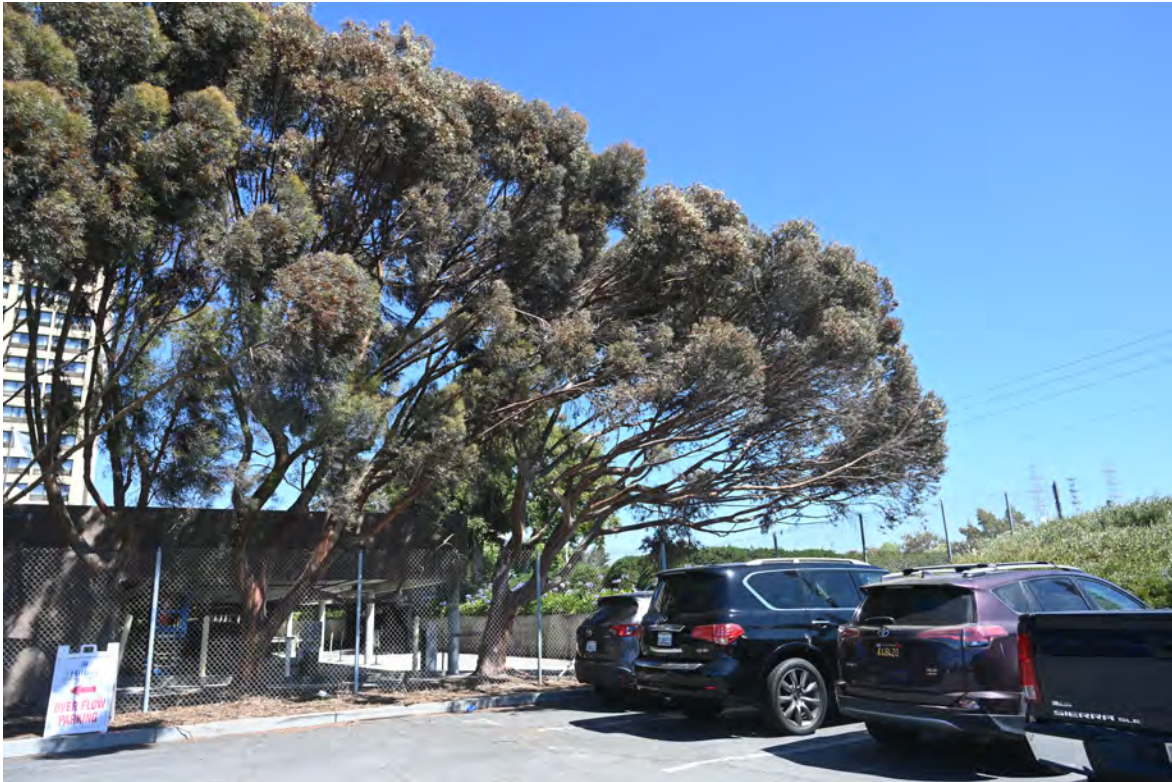
The trees were previously topped and now have extended limb forms.

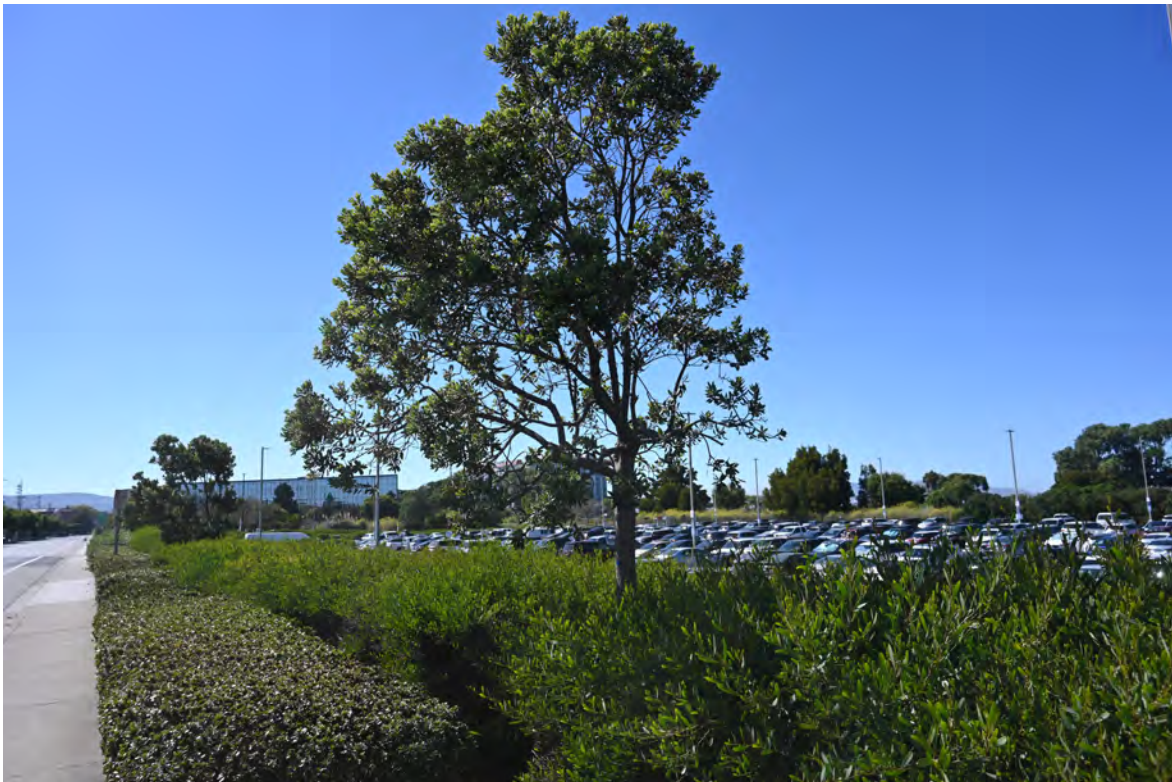
One of the seven New Zealand Christmas trees is located in the Airport Blvd. frontage.

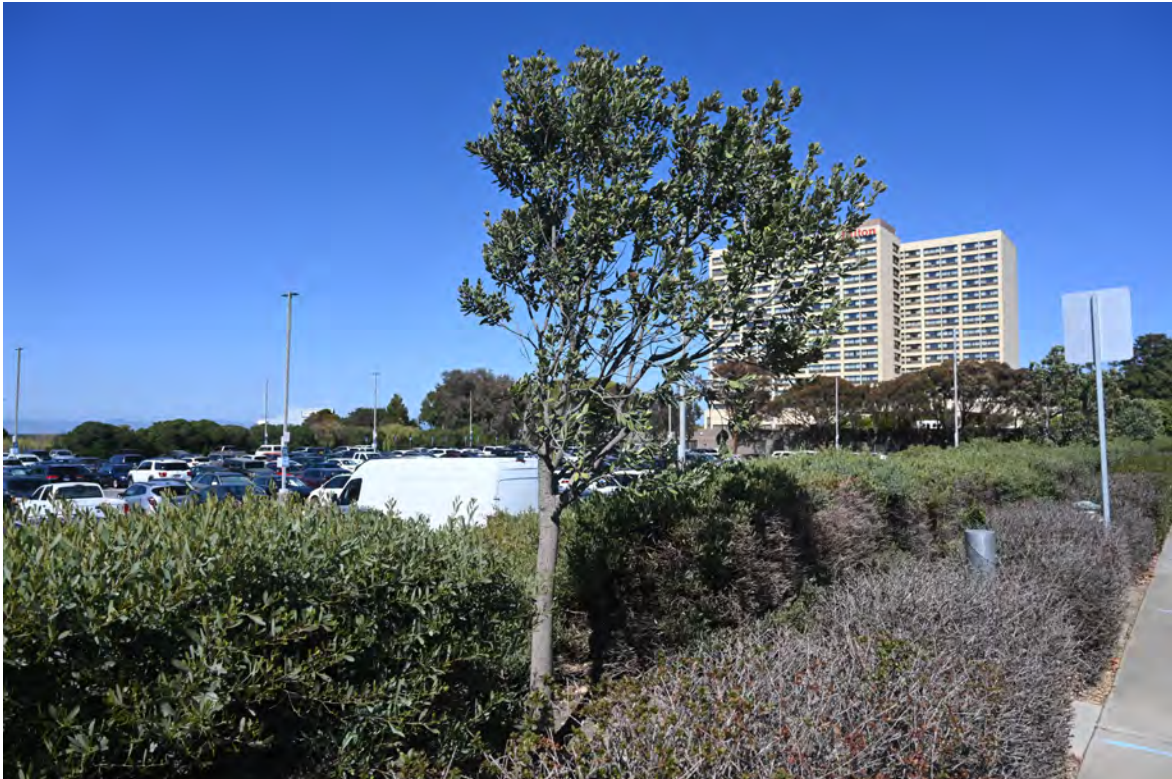
New Zealand Christmas trees are in variable condition, with this one in an area where the irrigation is apparently not functioning.

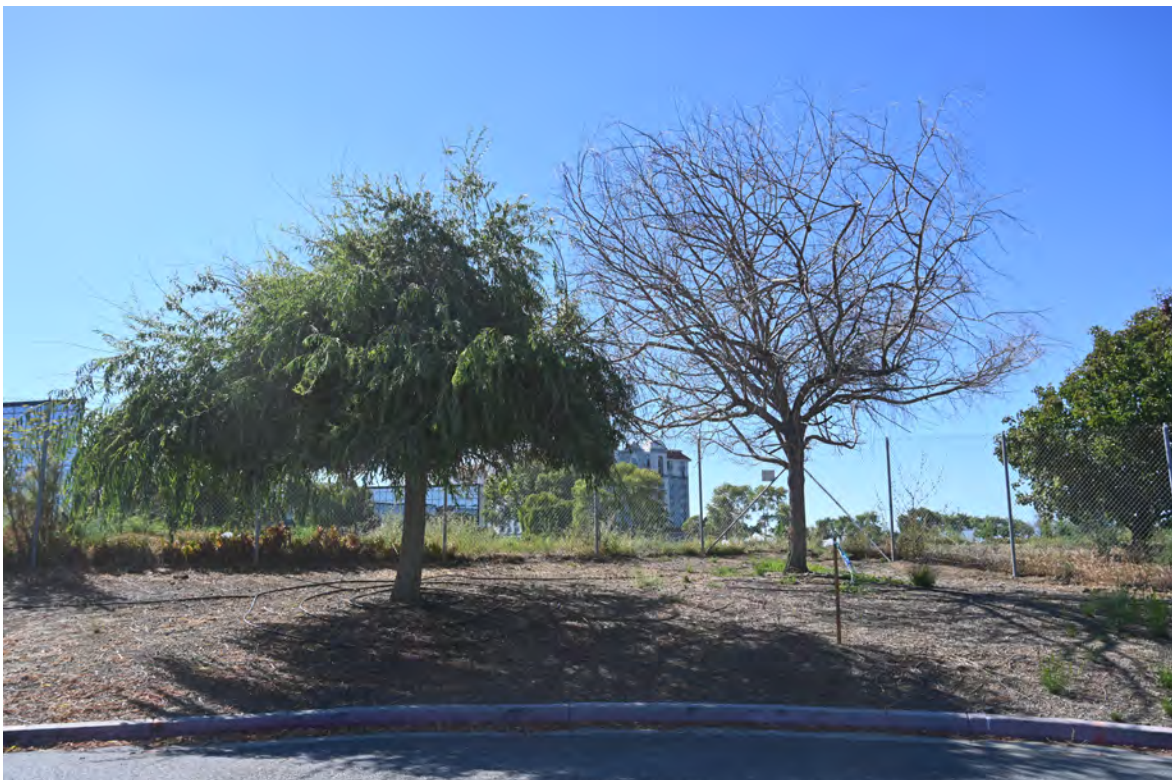
One of the two weeping willows is located on the west side of the parking lot. The third tree is dead.

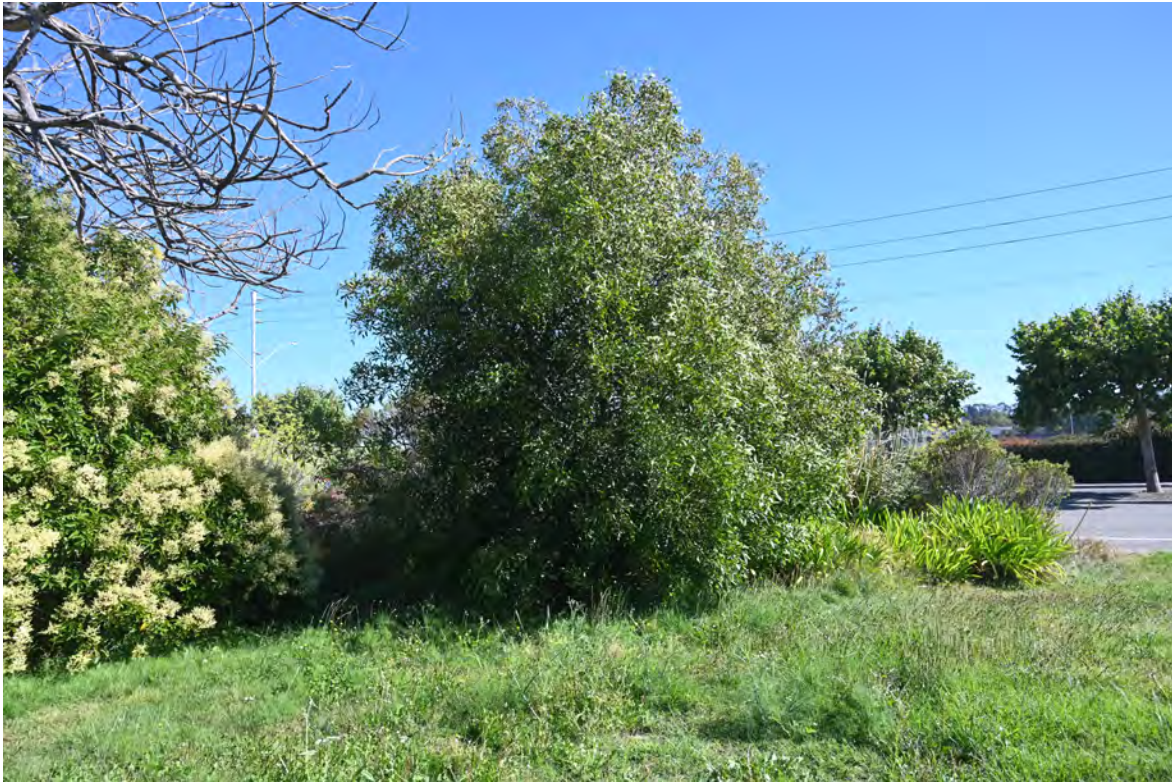
The golden wattle is located on the state property (tree #35).

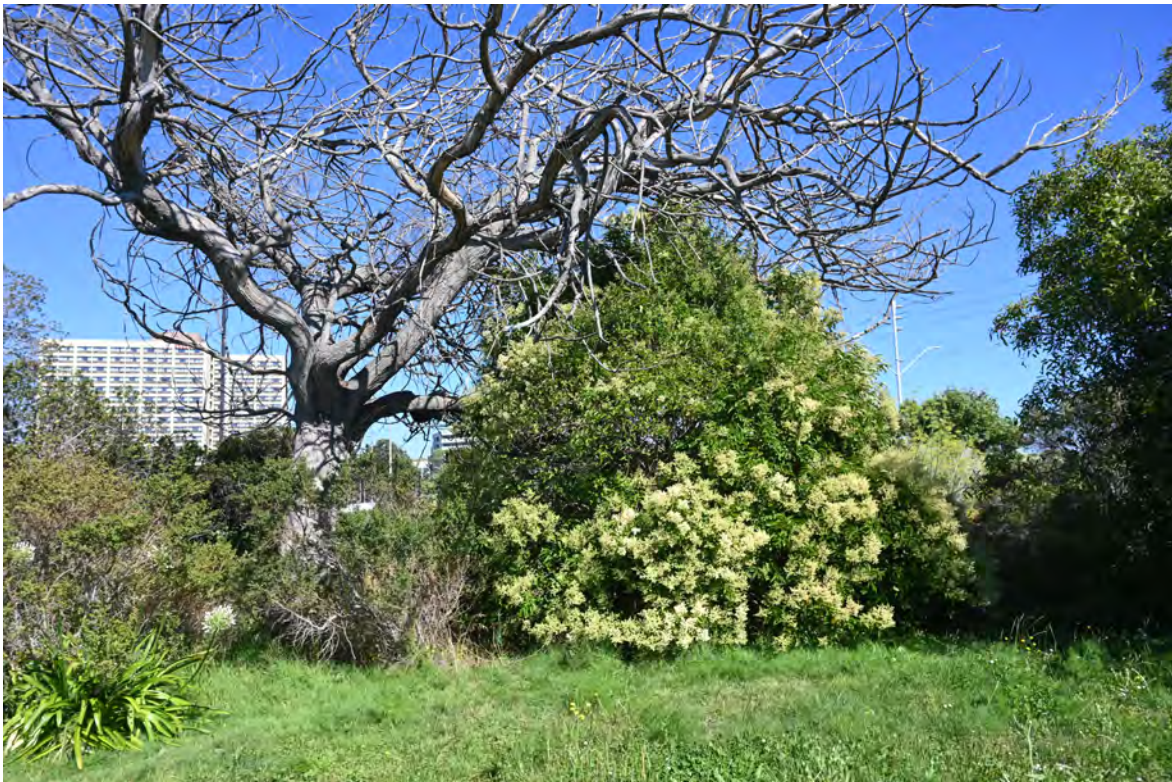
The glossy privet (tree #36). Likely originated as a volunteer seedling.

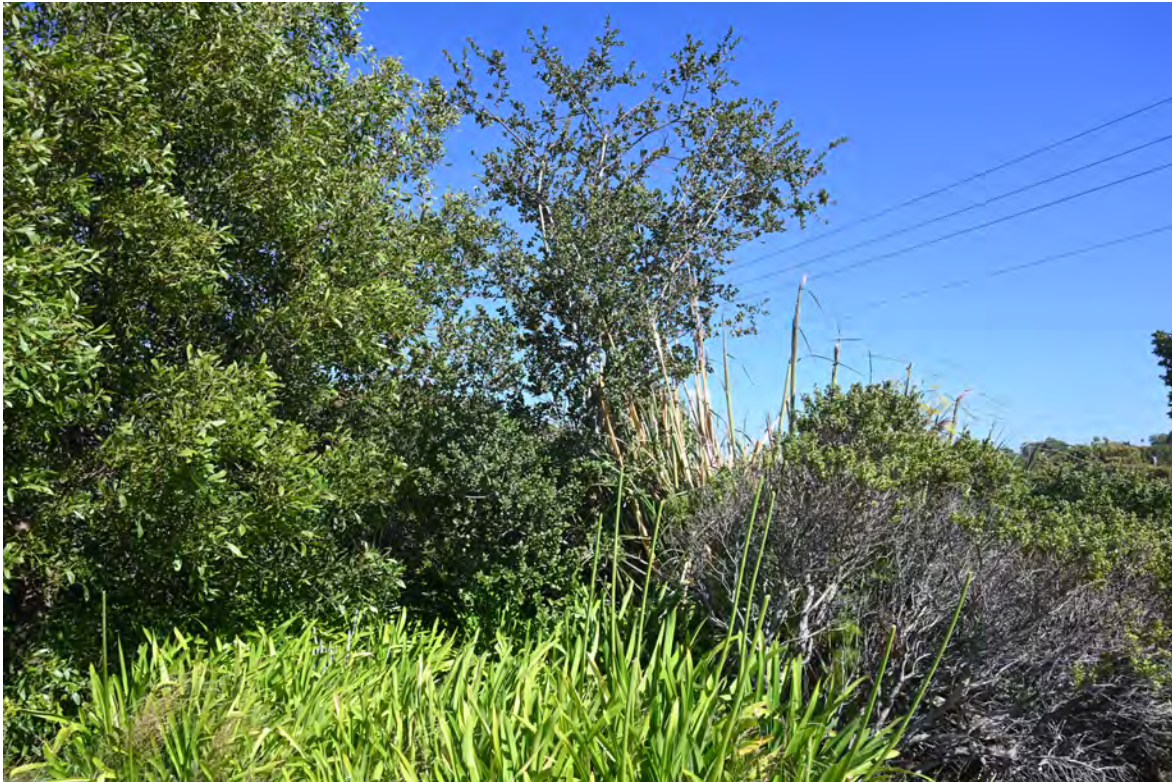
A young coast live oak, also likely a volunteer tree (#37).

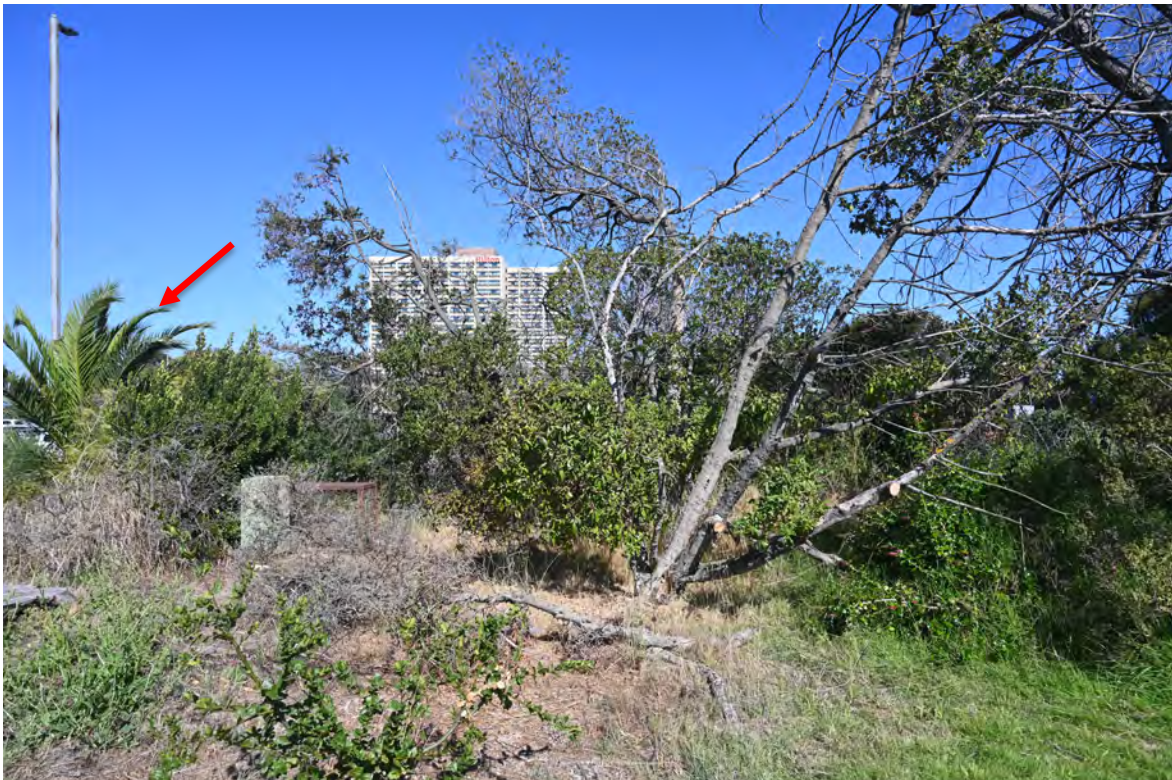
Several trees and shrubs have declined in this area. The volunteer Canary Island date palm was not included in the inventory (arrow).

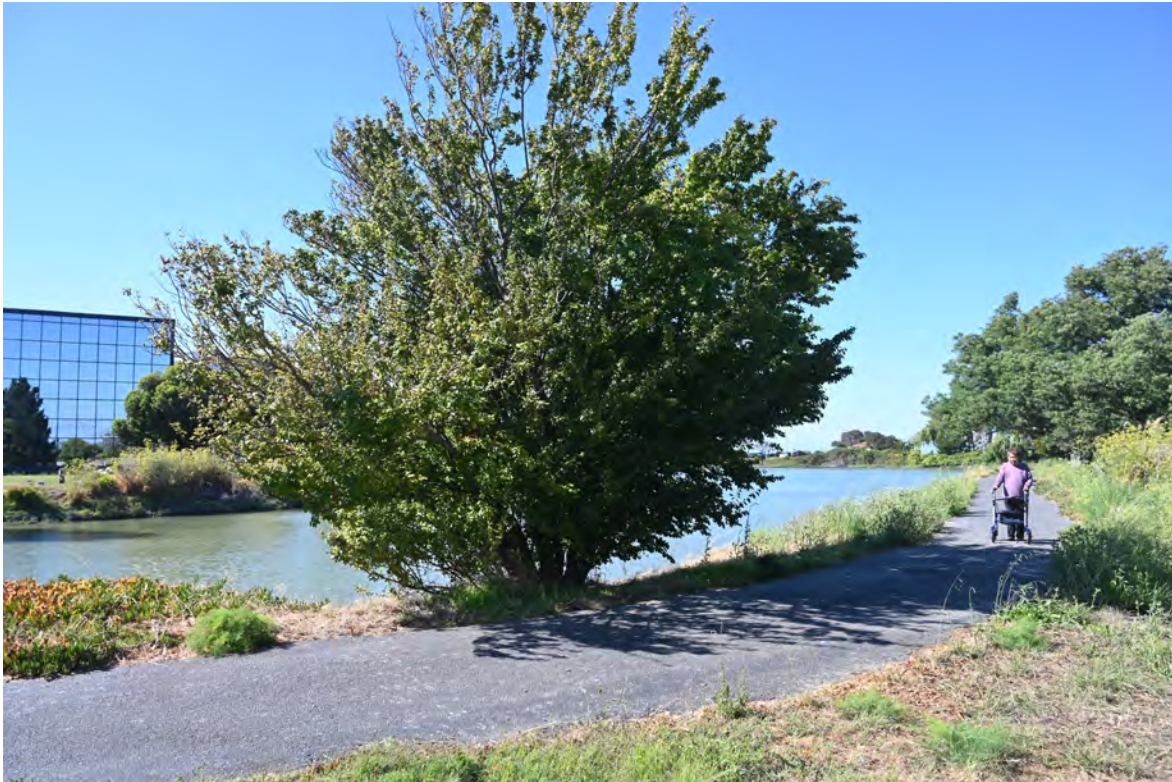
A cherry plum is growing next to the pathway (#38).

38	plum (<i>Prunus cerasifera</i>)	1 to 4	15±	20'±	25'±	n/a	3.0	2.0	Dense multiple trunk structure. Possibly originated as a volunteer seedling. Vigor and foliage density are moderate.	?	Fair
39	silver wattle (<i>Acacia dealbata</i>)	23	1	35'-40'±	40'±	n/a	3.0	2.5	Mature tree with symmetrical crown form and extended limb structure. Vigor and foliage density are moderate. Classified as an invasive species.	Yes	Fair to Moderate
40	silver wattle	11	1	20'±	20'±	?	3.0	1.5	Collapsed tree located at fence line. Portion may extend past fence.	No	Poor
41	silver wattle	9; 12	2	30'±	25'±	10'	3.0	2.0	Old, partially collapsed tree located at fence line. Single trunk structure. Vigor and foliage density are moderate.	Yes	Fair
42	flowering pear (<i>Pyrus calleryana</i>)	3 to 6	6	15'±	20'±	n/a	3.0	2.0	Low, multiple trunk structure. Vigor and foliage density are moderate.	No	Fair
43	blackwood acacia (<i>Acacia melanoxylon</i>)	2 to 6	thicket	20'±	40'±	n/a	3.0	2.0	Dense thicket of volunteer seedlings and root sprouts. This species is considered invasive.	No	Poor to Fair

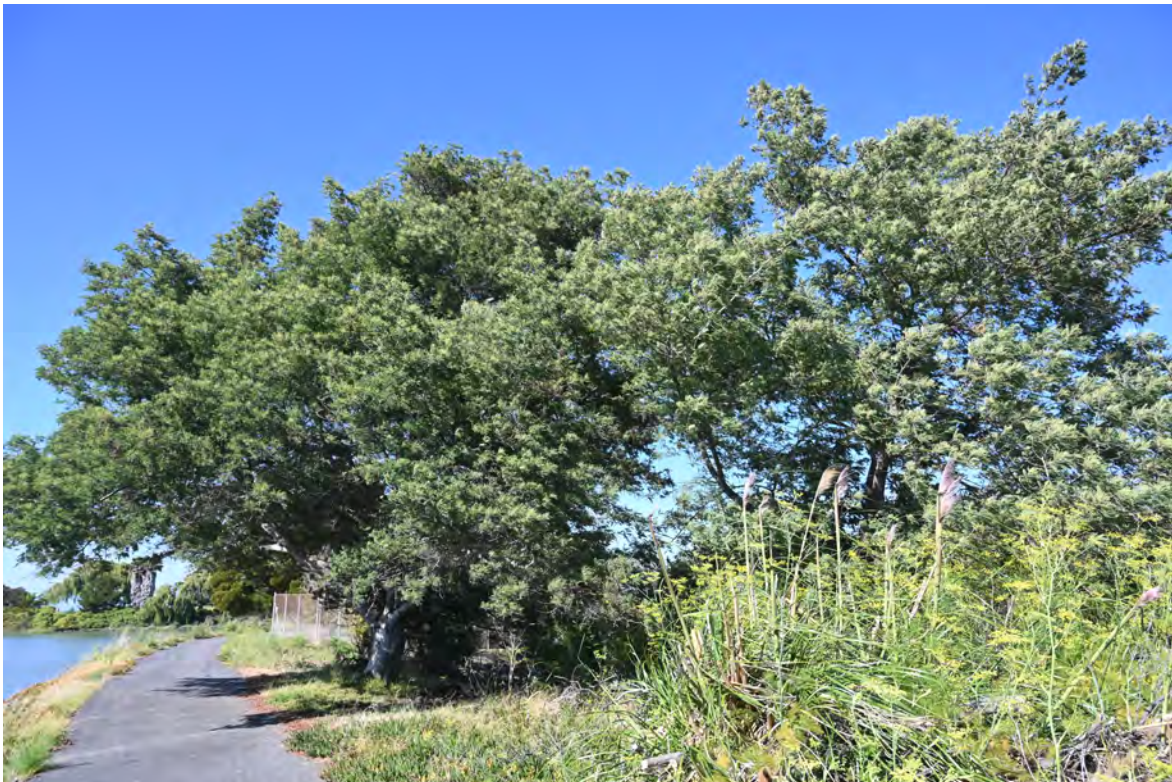
A group of three silver wattles (acacia). Two of the trees have collapsed in the past.

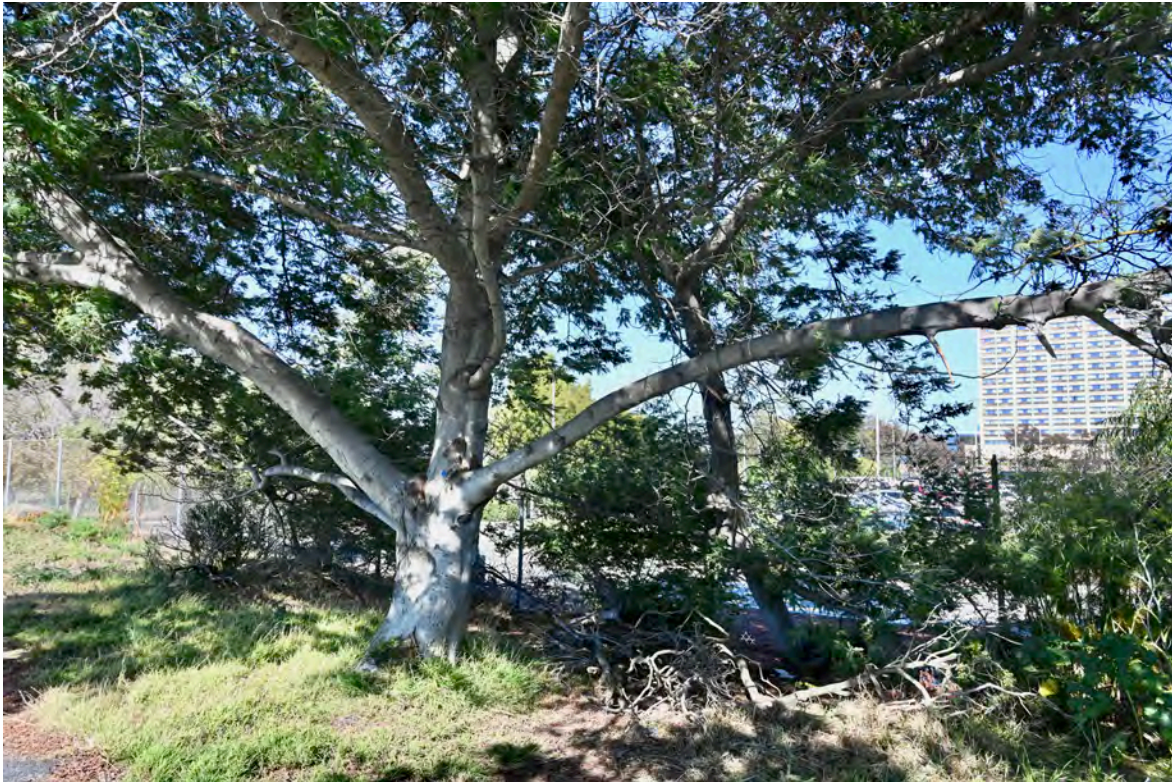
The largest of the silver wattles is tree #39.

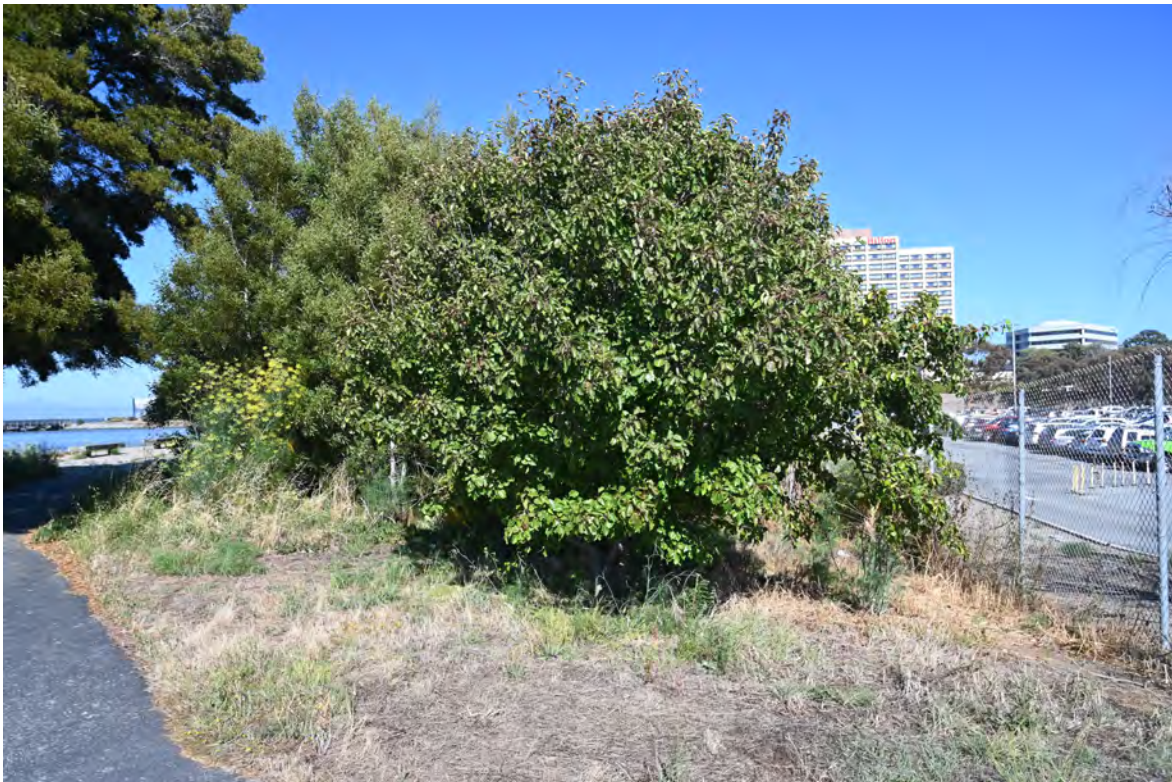
One of the three flowing pears is located along the pathway (tree #42).

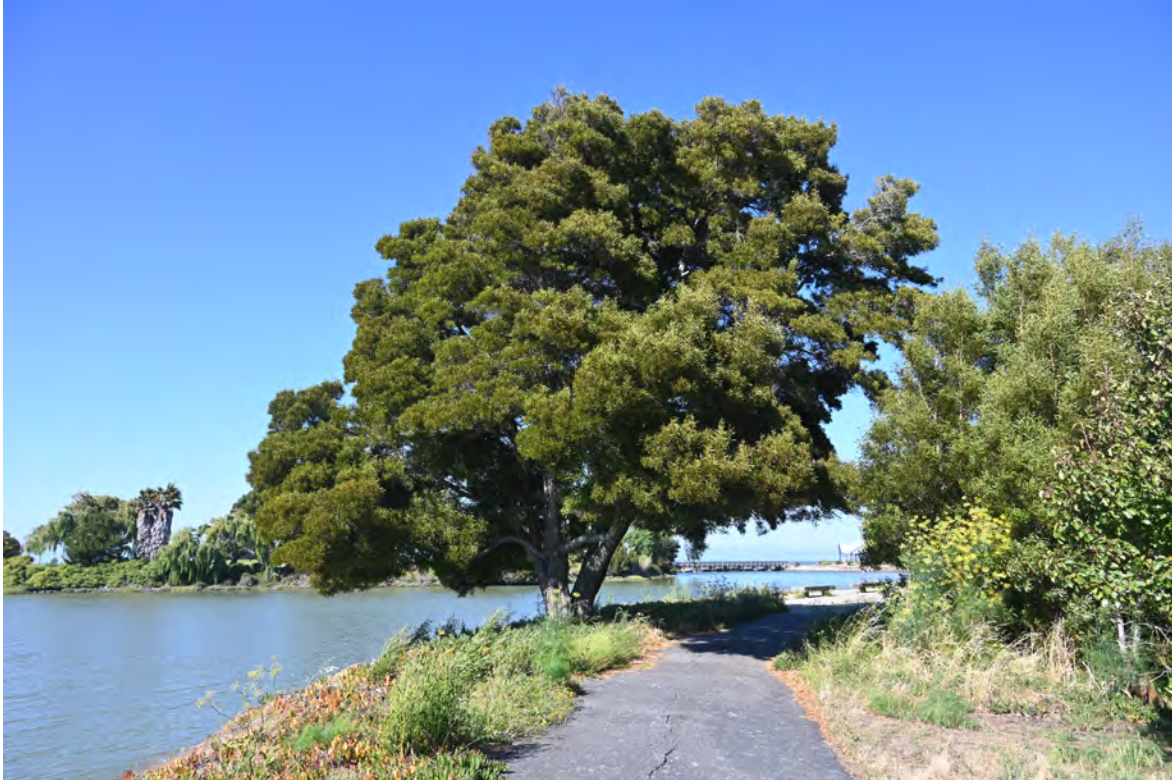
A mature blackwood acacia (tree #43).

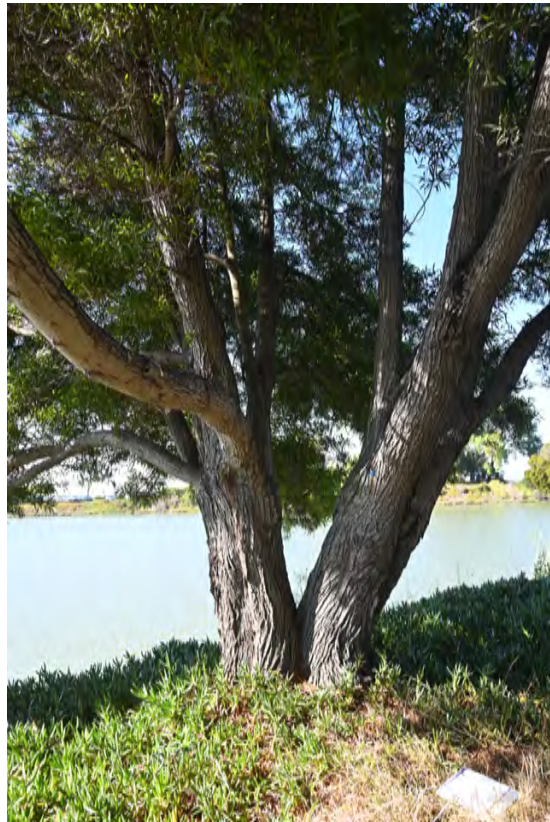
The low, co-dominant trunk structure of the blackwood acacia.
