Appendix E – Tree Inventory and Evaluation

August 22, 2021

RE: 620 Airport Blvd., Burlingame- Tree Inventory and Evaluation

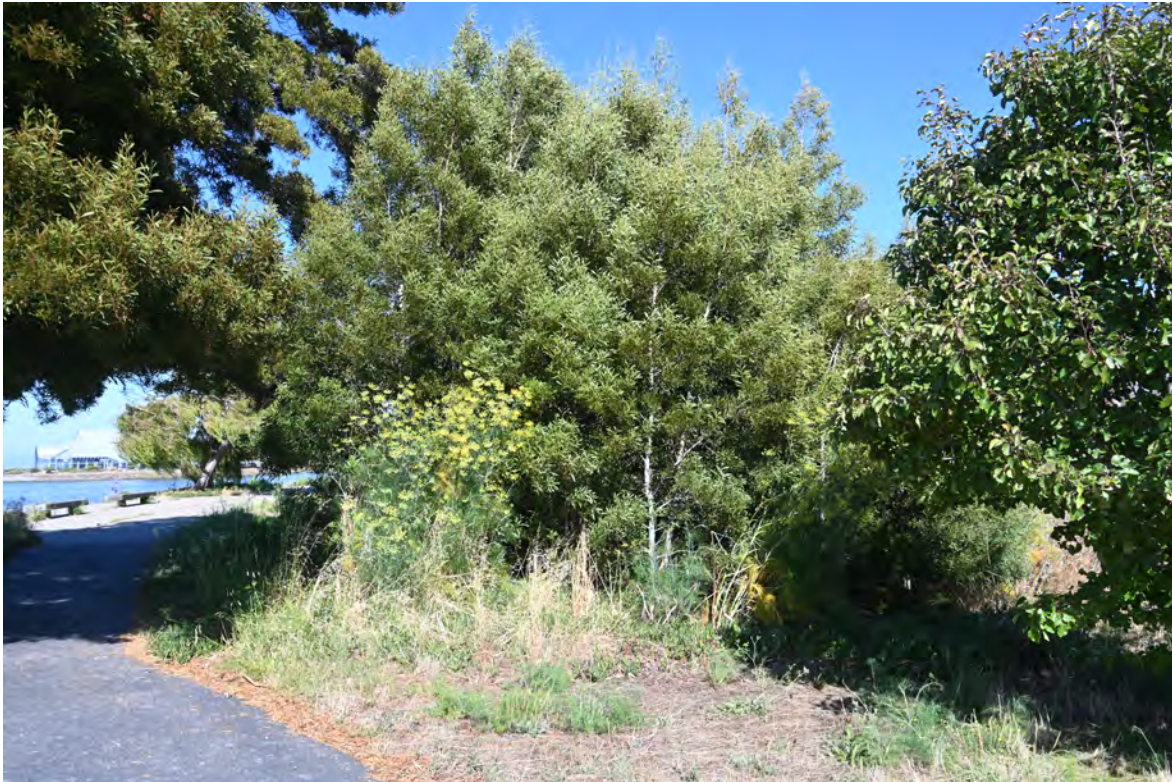
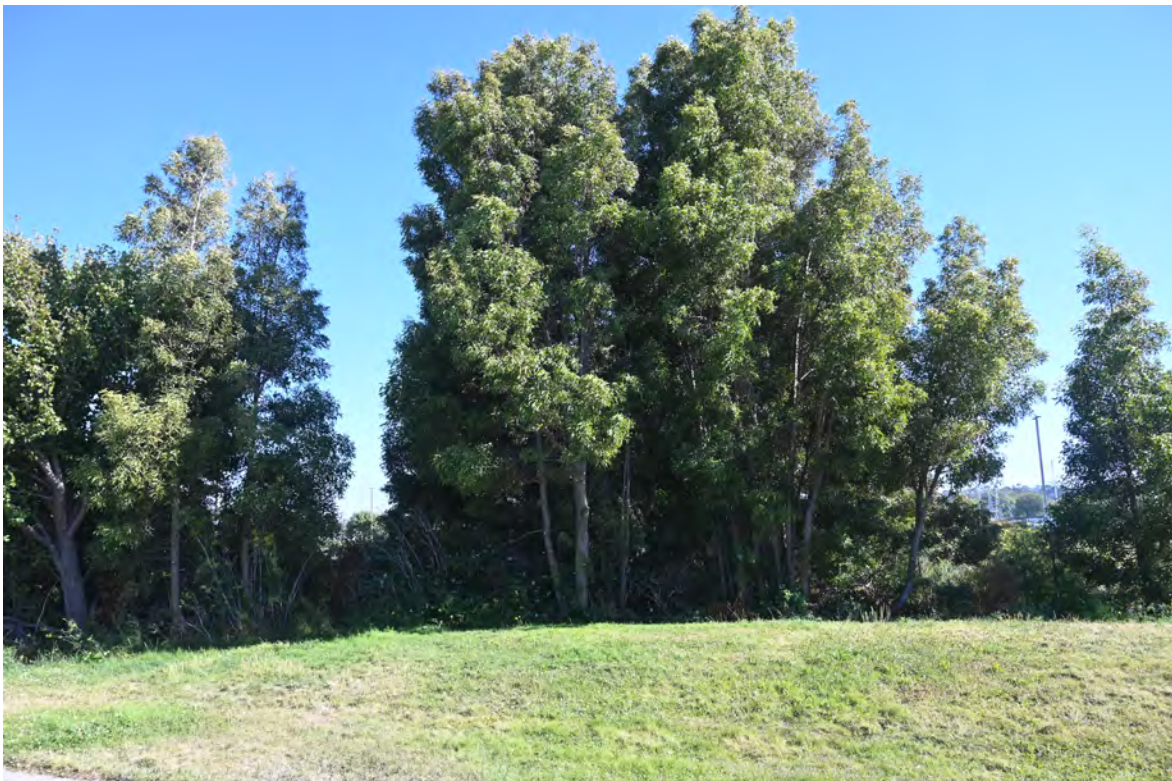
Thickets of blackwood acacia have established within the area. Blackwood acacia is considered an invasive species.

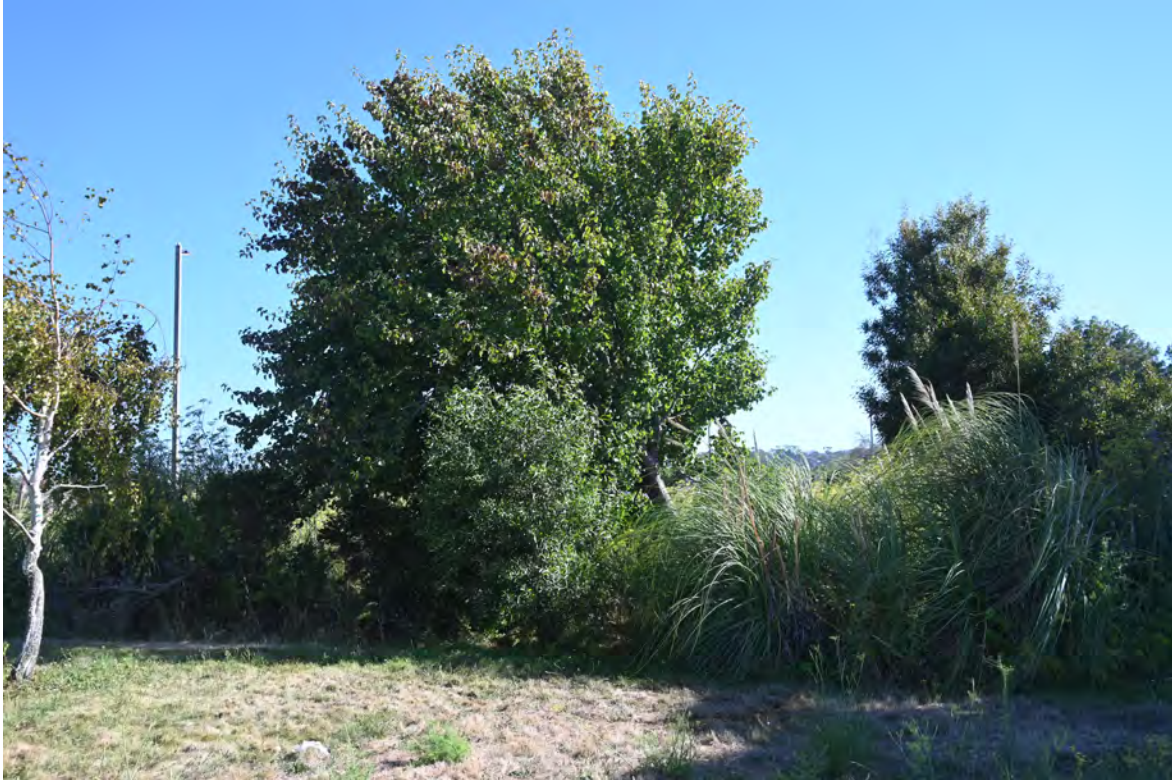
Tree #45, a flowering pear with a significant trunk lean.

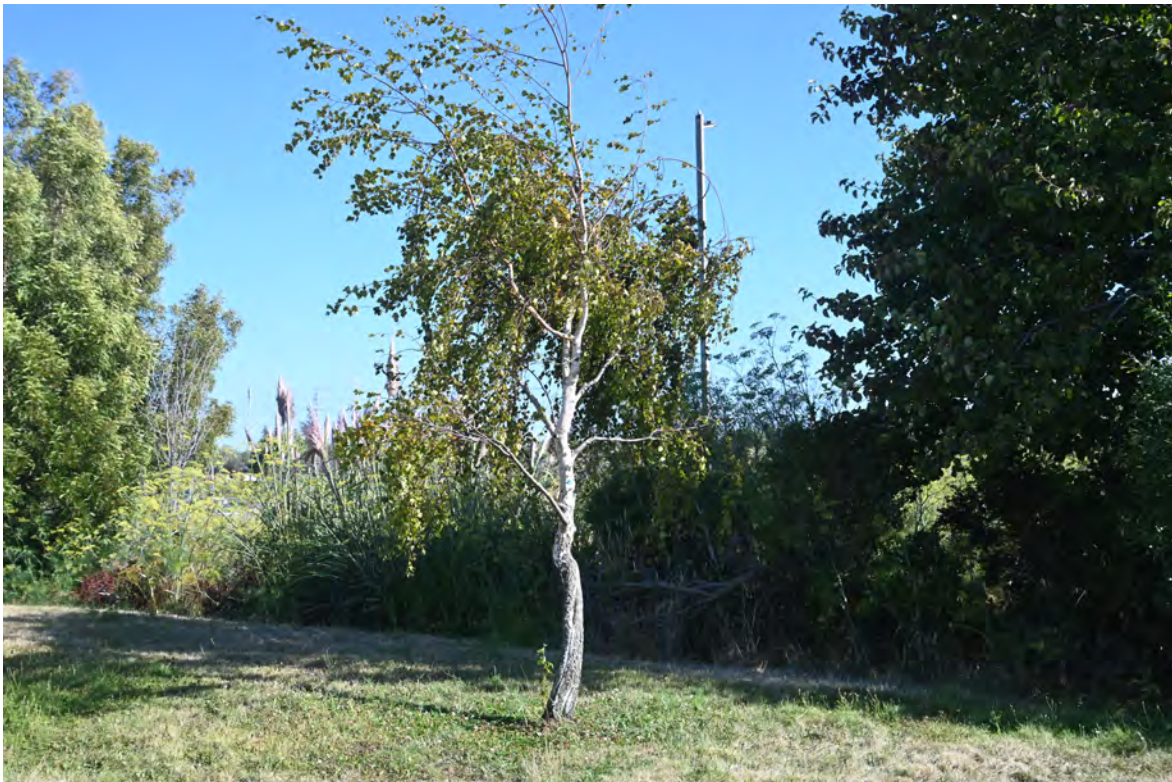
Tree #46, a white birch in decline.

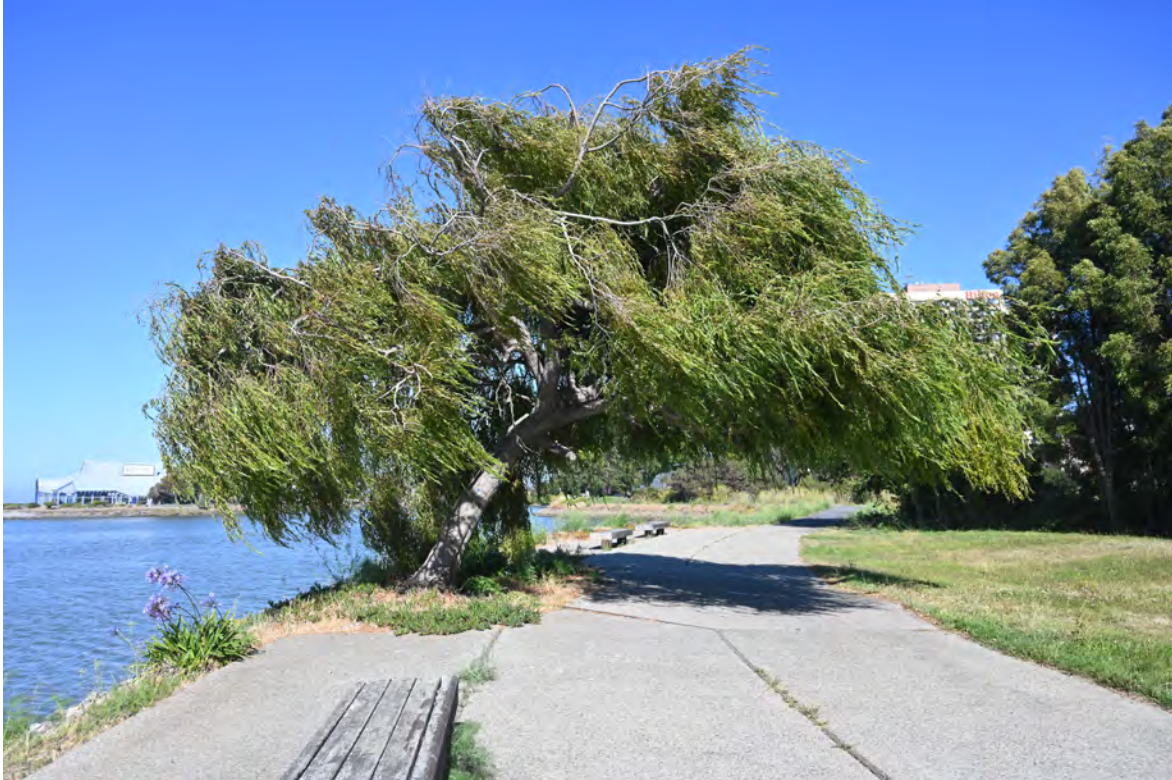
Tree #47, a weeping willow with a trunk lean.

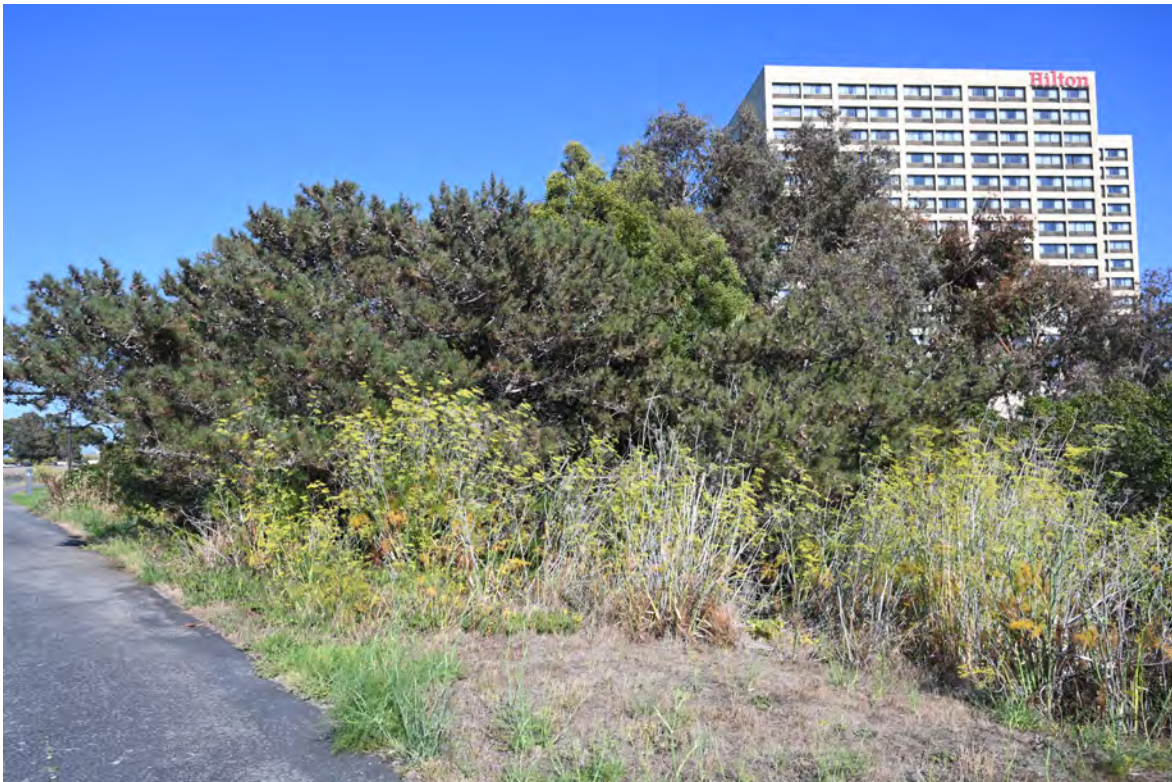
Two Monterey pines (trees #50 and #51) are located in the northeast corner of the state property.

48	blackwood acacia	2 to 10	thicket	40'±	50'±	n/a	3	2.5	Dense thicket of volunteer seedlings and root sprouts.	No	Poor to Fair
49	flowering pear	12.5	1	20'±	20'±	n/a	3	2	Marginal structure with closely spaced, multiple limb attachments. Vigor and foliage density are moderate.	No	Fair
50	Monterey pine (<i>Pinus radiata</i>)	20	1	25'±	40'±	n/a	2.5	2	Low, wide crown form. Lower trunk covered in ivy. Moderately low vigor and foliage density. Possible pine pitch canker infection.	Yes	Fair
51	Monterey pine	8 low	3	20'±	30'±	n/a	2.5	2	Low, multiple trunk structure. Moderately low vigor and foliage density. Possible pine pitch canker infection.	No	Fair
