Tree Inventory Report

**1095 Rollins Road
Burlingame, CA**

November 21, 2018

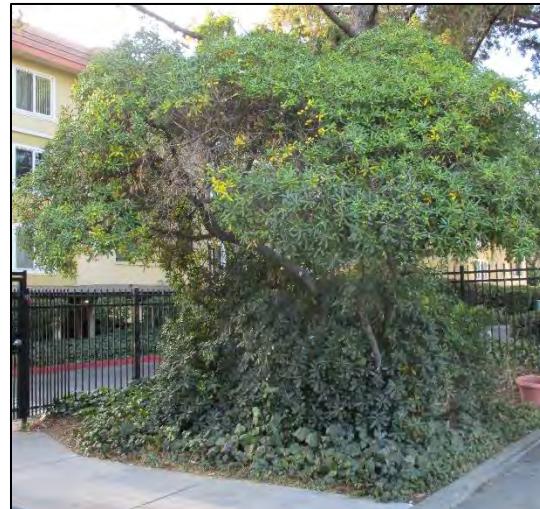
- A small Pittosporum shrub/tree (#137) was in fair condition growing in the south eastern corner of the property (Photo 1).
- A small olive (#143) in fair condition was covered in ivy along Rollings Road.

Photo 1 – Tobira #137 was a short shrub-like tree.

| Tree No. | Species | Trunk | Protected | Condition | Suitability for | Comments |
|---|---|---|---|---|---|--|
| 137 | Tobira | 5,4,3 | No | 3 | Moderate | Multiple trunks arise from base; growing as a shrub. |

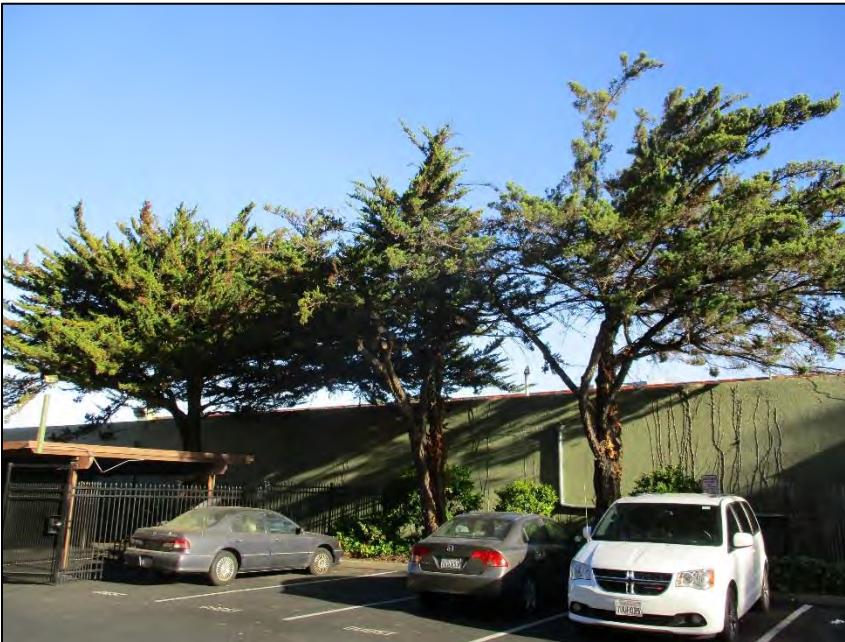
- Three Monterey pines (#135, 136 and 138) were growing in the southwestern corner of the property. They had trunk diameters of 22, 22 and 26" respectively and were in fair condition.
- Four Monterey cypresses (#139-142) were growing along the southern boundary. They were mature in development with at least one trunk 18" or greater in diameter. They were in fair condition except for #140 which had a thinner crown than the others (Photo 2).
- Chinese elm #144 was semi-mature and growing near the eastern property boundary.

Photo 2 – Monterey cypresses #142-140 (left to right) were growing along the southern property boundary.

| Tree No. | Species | Trunk | Protected | Condition | Suitability for | Comments |
|---|---|---|---|---|---|--|
| 140 | Monterey cypress | 21 | Yes | 2 | Low | Off-site; minimal overhang; topped at 20'; thin. |
| 141 | Monterey cypress | 18,12 | Yes | 3 | Low | Off-site; minimal overhang; topped at 20'; full crown |
| 142 | Monterey cypress | 18,16 | Yes | 3 | Moderate | Off-site; minimal overhang; codominant trunks arise from 5'; topped at 20'; full crown; roots lifting asphalt. |
