620 Airport Boulevard Redevelopment Project

Avian Collision Risk Assessment Report

January 2023 | 02816.00021.001

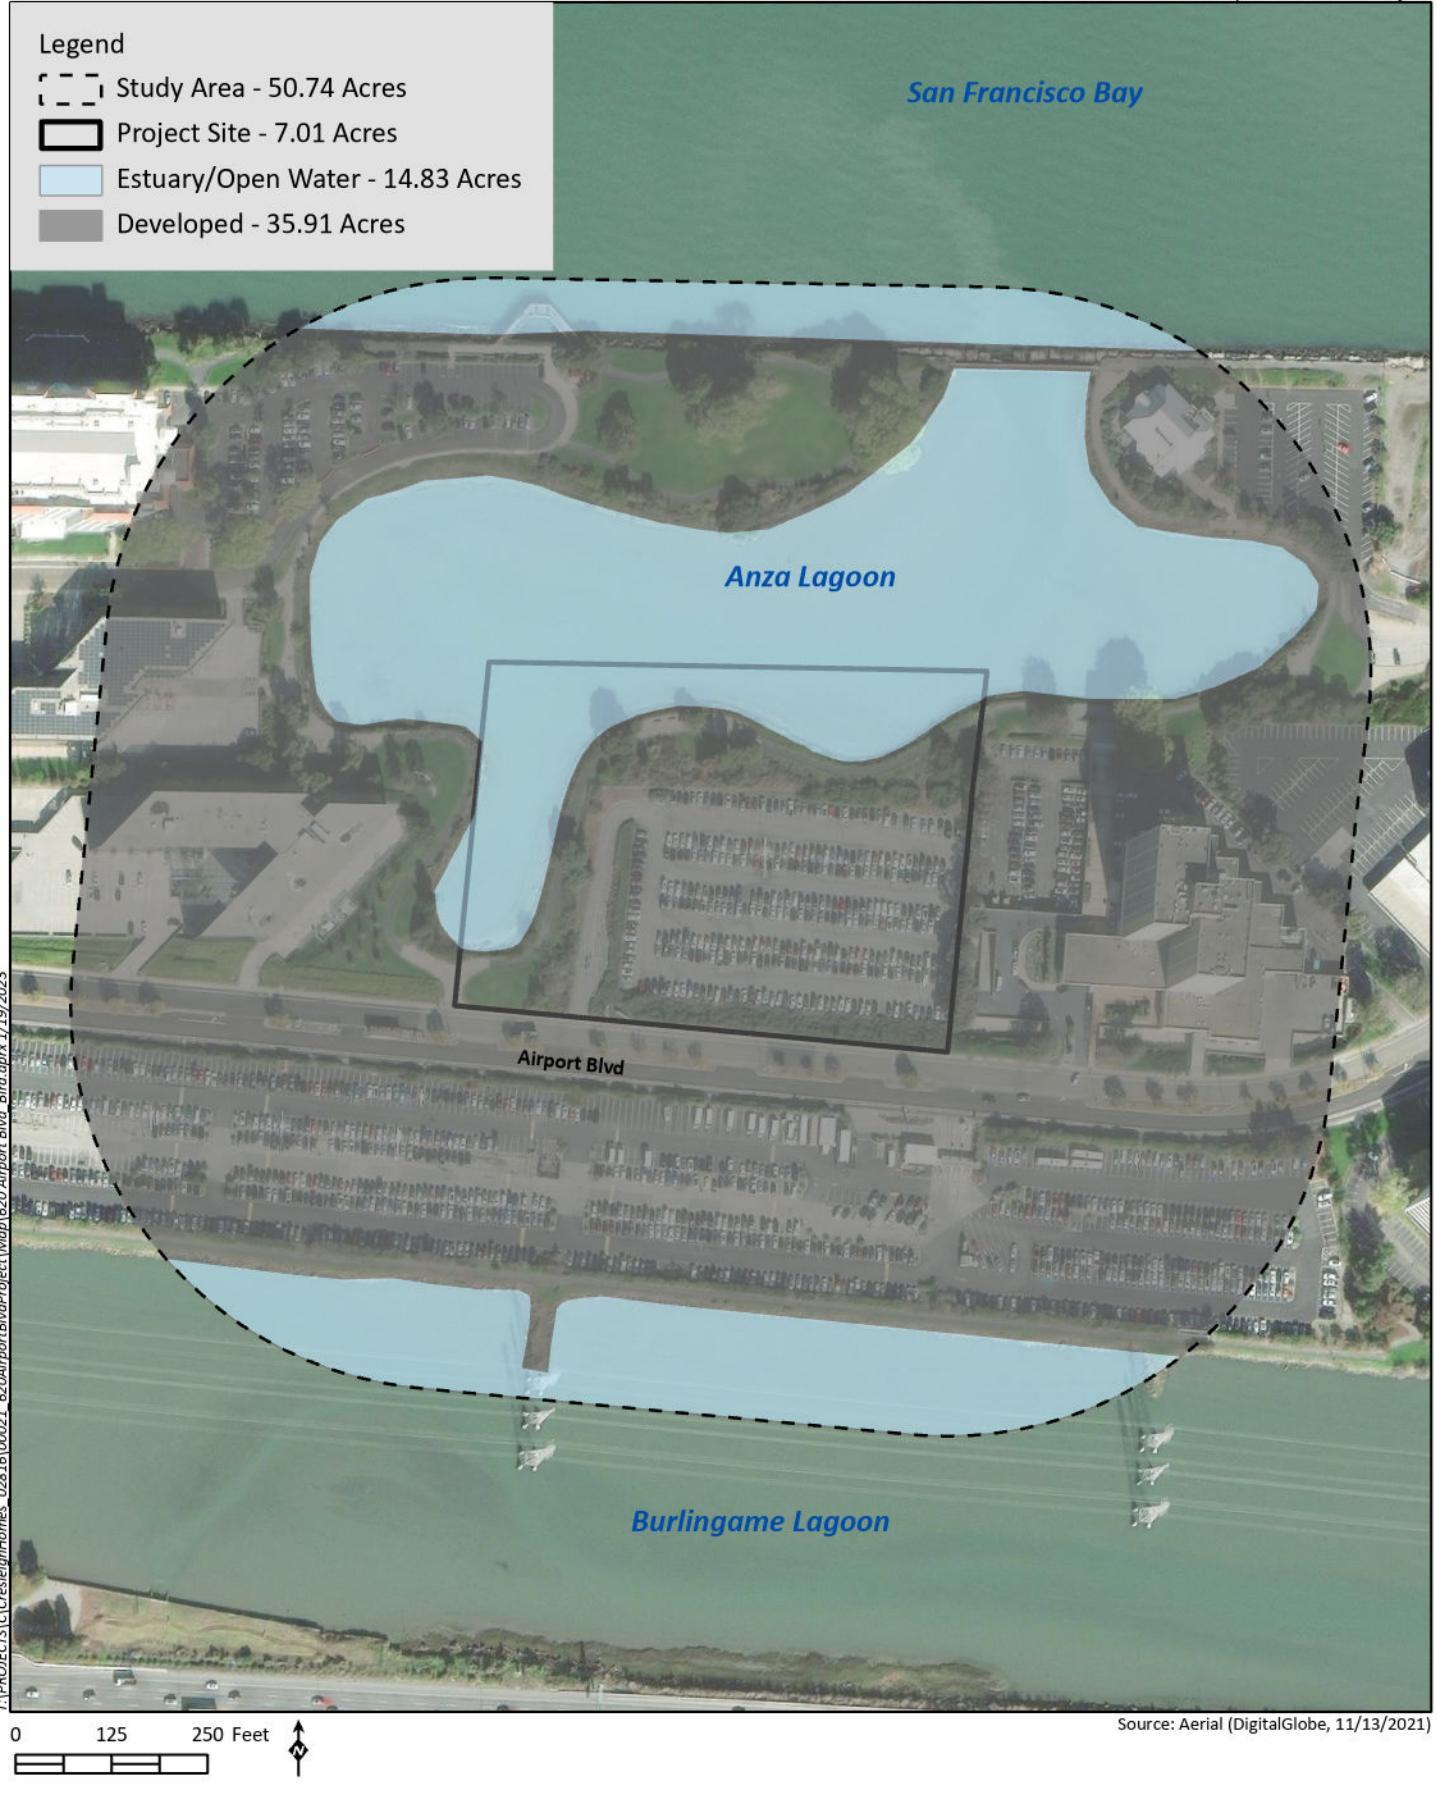
Biological Communities

The Study Area consists entirely of developed land and estuarine/open water habitat (Appendix A, Figure 4). These habitat types are discussed below and were previously described in the biological resources evaluation prepared for the project in 2022 (HELIX 2022). Representative site photographs are included in Appendix C.

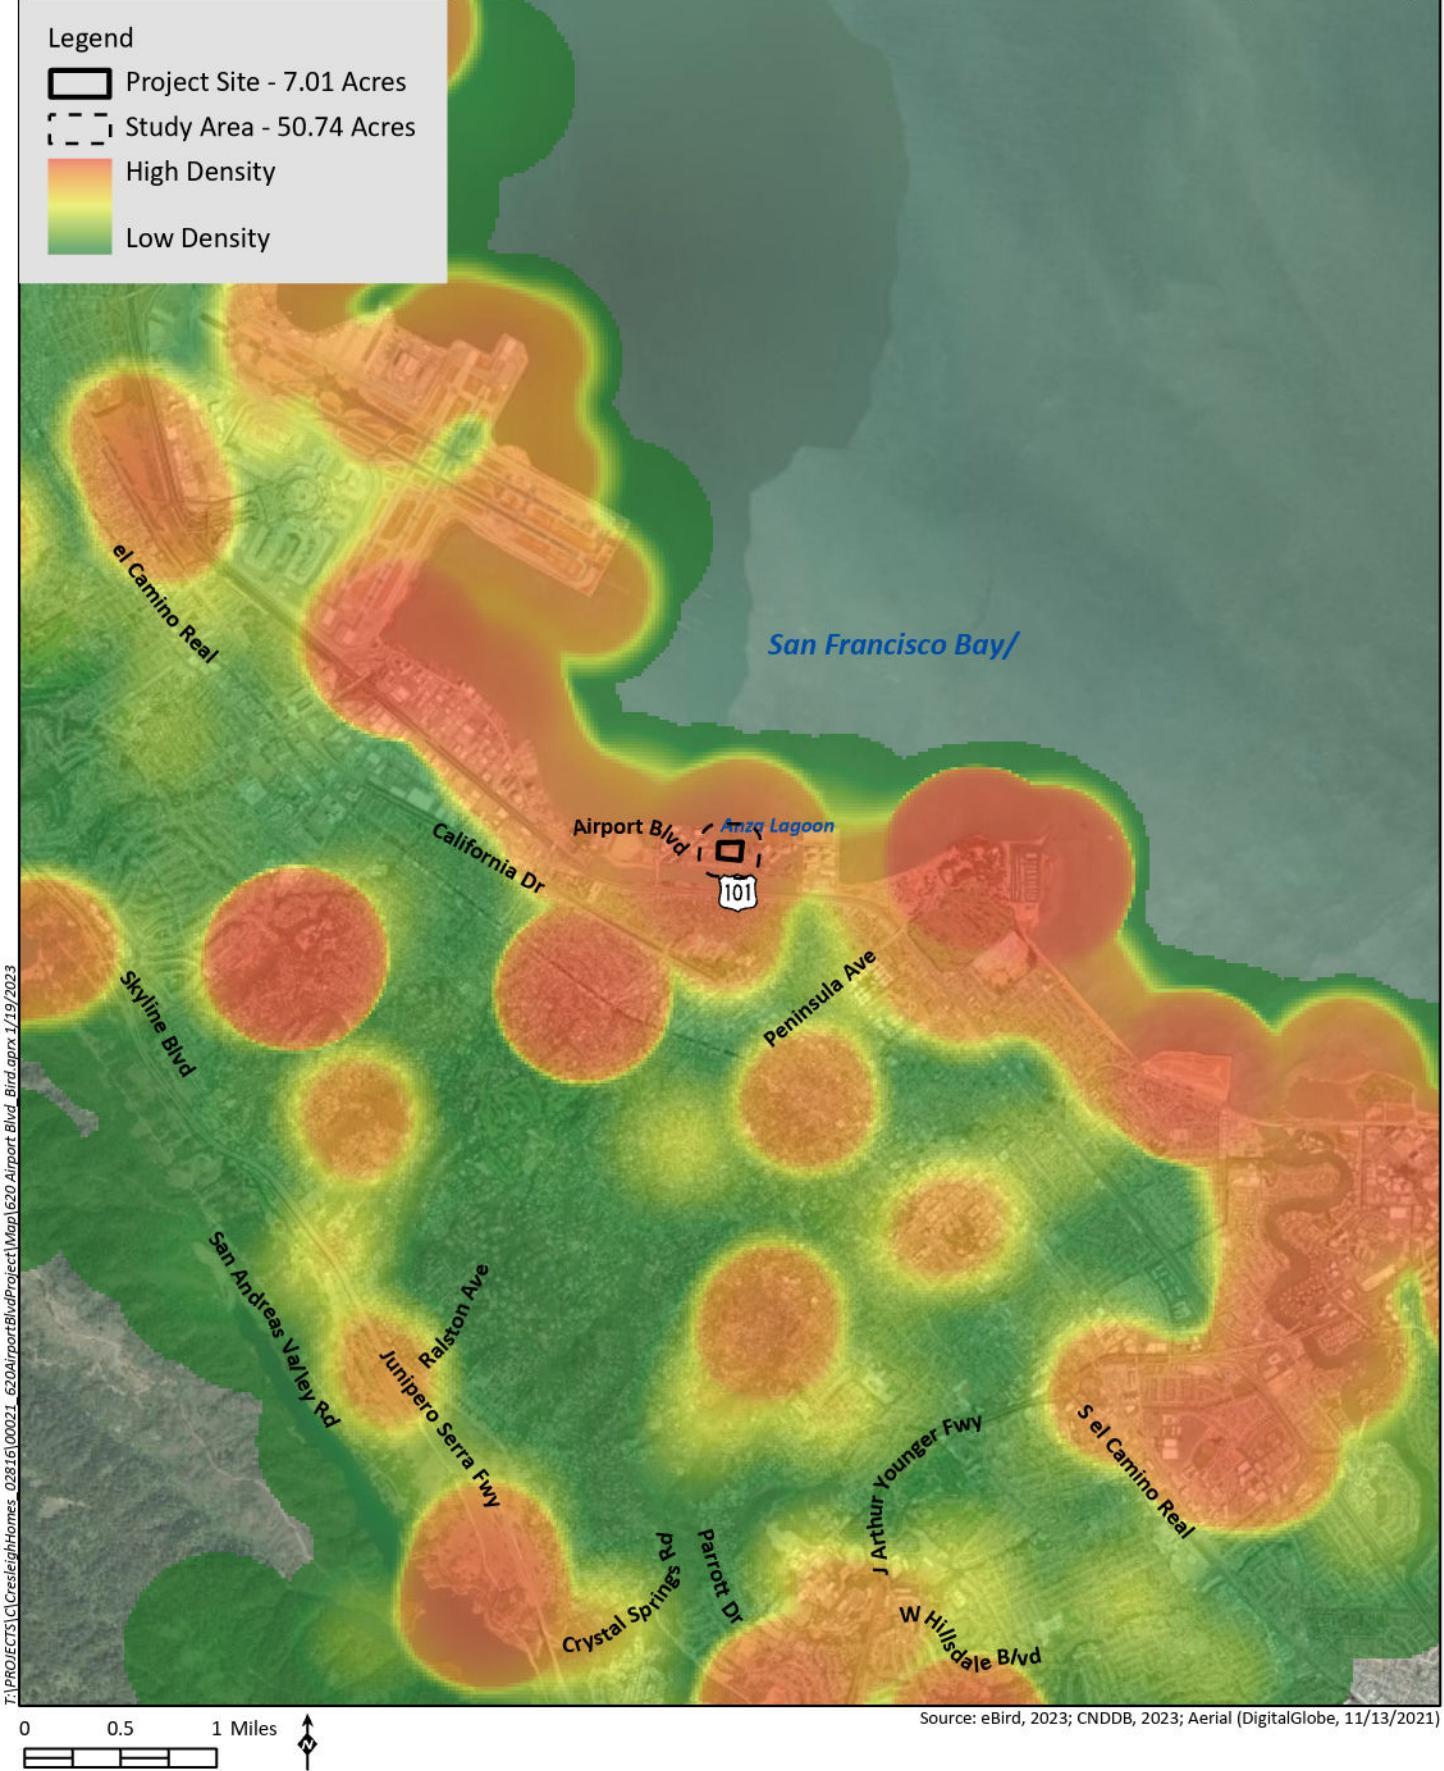
Bird Density Map

Bird density in the Study Area and the surrounding region has been provided in Appendix A, Figure 5. Data showing bird density has been provided by CNDDB (CDFW 2023) and eBird (Cornell Lab of Ornithology 2023). Bird density in the region of the project site is highest along the coast of San

Francisco Bay that includes Anza Lagoon where the project is situated and other coastal habitats (Cornell Lab of Ornithology 2023; CDFW 2023). Other inland bird hotspots are present in areas that appear to be developed. However, bird density along the coast is a continuous band of high-density areas where birds have been observed and documented. Bird density data from eBird displays where most bird observations have been documented and may be biased towards where birds are most observable or where observers frequent the most compared to other locations.

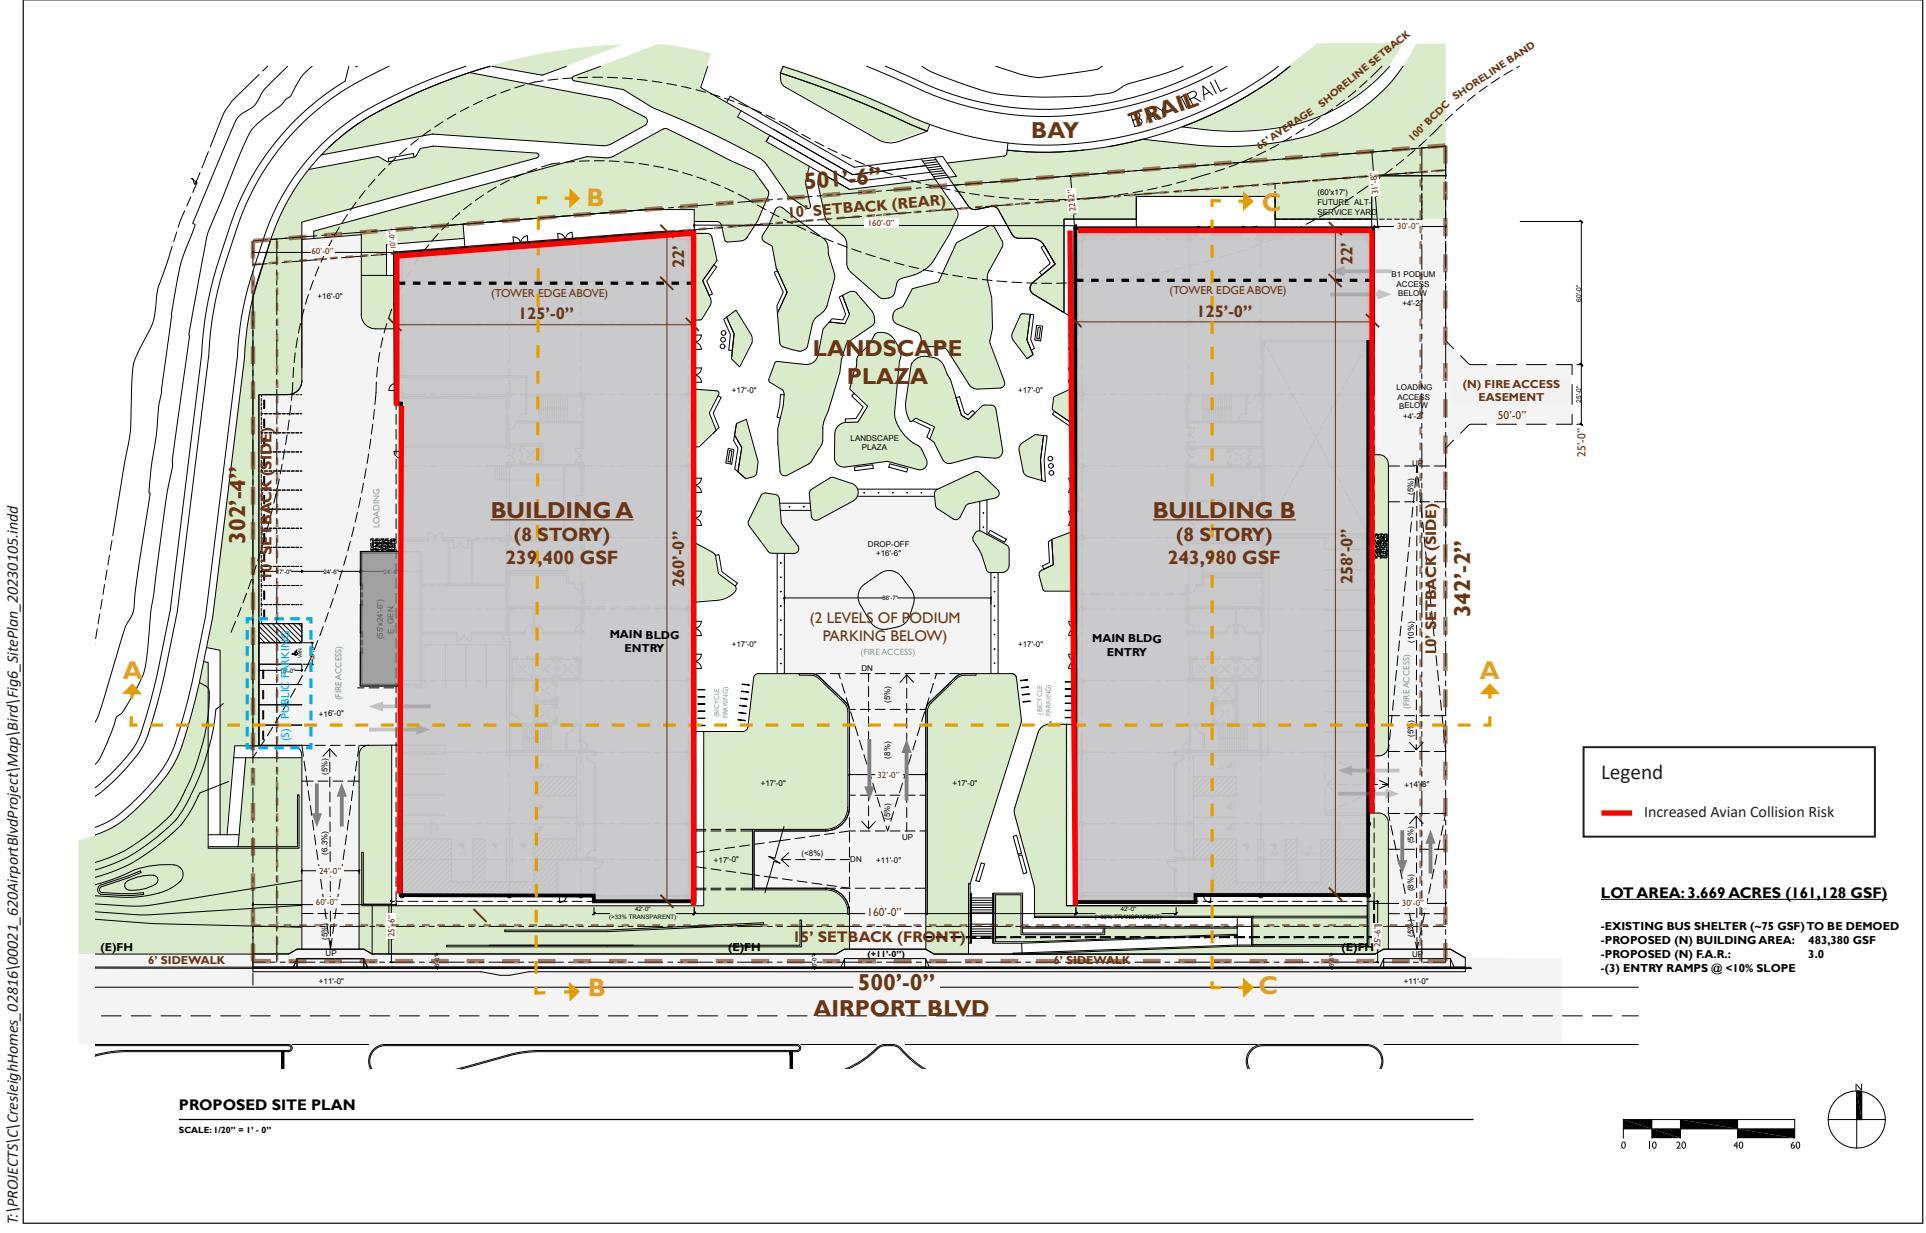
Site Plan

The project proponent is proposing to redevelop the existing asphalt metered parking lot by building a new life science/office development on the 7.01-acre project site. The approximately 484,000 square foot project concept consists of two 9-story buildings (6-stories of commercial uses and 3-stories of inbuilding parking) over partially subterranean podium-level parking with approximately 868 on-site parking spaces. An option for additional parking spaces may be available through a shared parking agreement with the adjacent hotel. Riprap, stabilized crushed rock, and unstabilized crushed rock will be placed in Anza Lagoon to stabilize the shoreline as part of the proposed project. The top of the proposed podium is designed to be an integrated plaza level where ground floor activities, building lobbies, amenities, and physical connection to the shoreline will be placed. The maximum height of the development is proposed at approximately 163 feet. The project has incorporated bird-friendly treatments into both building designs and on all sides of each building. Exterior glazing composed of 45 percent opaque glazing is proposed. The exterior glazing system utilizes shadow boxes (recessed surfaces) to the variegate exterior appearance and break up the glass surface. Mullion extensions are provided in a random pattern to break up exterior expanses of glass, with the exception of mullion

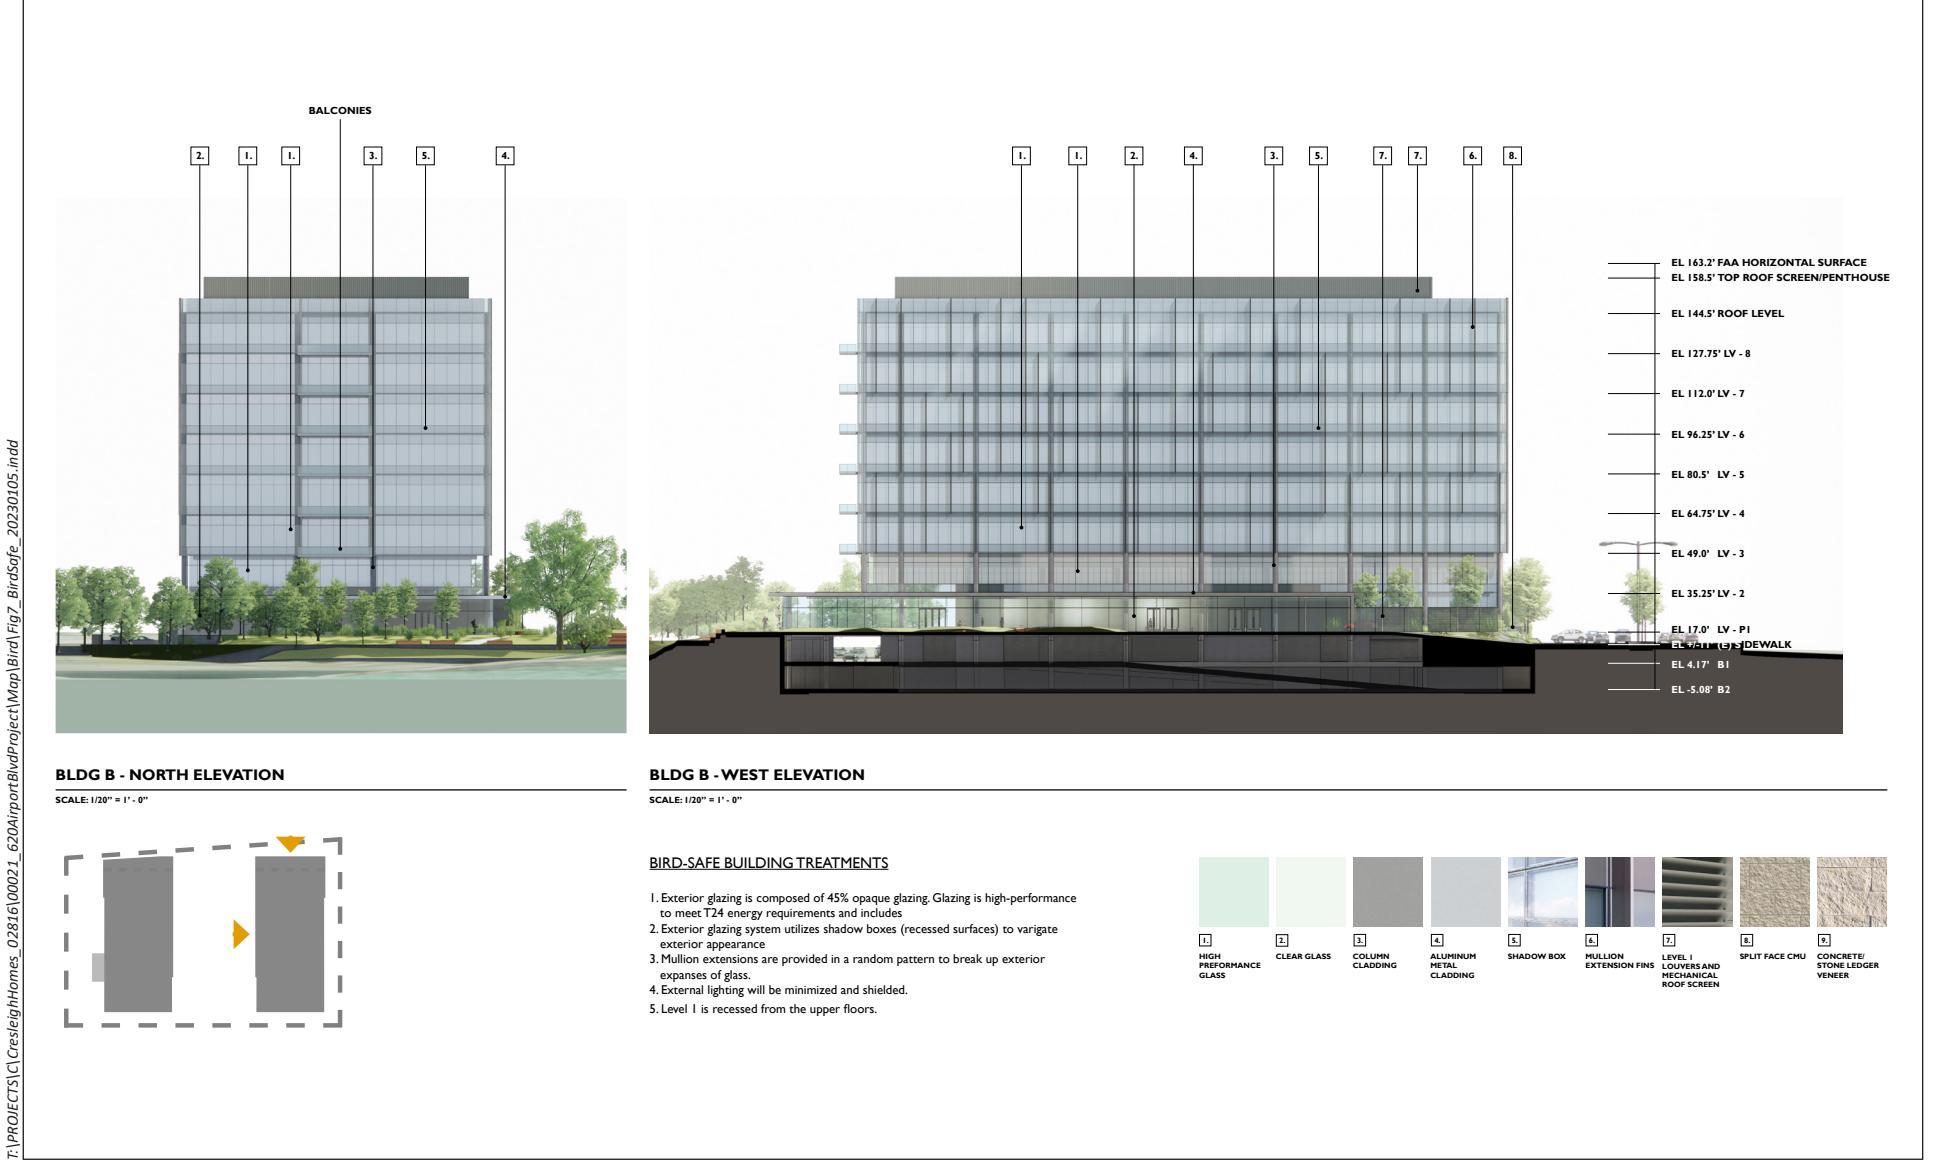
Bird Safe Building Design

The proposed building design has incorporated several bird-friendly design elements that would reduce the frequency and likelihood of avian collisions (Appendix A, Figure 7). The building will incorporate exterior glazing on Levels 2-8, which is composed of 45 percent opaque glazing that will reduce the transparency of the glass and gives it the appearance of an opaque surface similar to frosted glass. This treatment reduces the transparency of the windows thus increasing the likelihood that birds will

The project design shows the use of clear glass on the ground level in close proximity to vegetation, with vegetation visible in the design rendering through the portion of the building that will use clear glass (Appendix A, Figure 7). Although clear or transparent glass will reduce reflections of vegetation onto the glass, clear glass as designed poses a feature hazard per the Standards Bird Safe Buildings (San Francisco Planning Department 2011) since birds do not perceive glass in the same manner as humans (Sheppard and Phillips 2015). Birds will attempt to pass through the glass to reach vegetation visible on the other side or, reflections of adjacent vegetation will be visible on the glass surface and birds may attempt to access the reflected vegetation. Gelb and Delacretaz (2009) analyzed data from Audubon's Project Safe Flight in Manhattan from 1997 to 2008 analyzed critical contributing factors for structures with the largest number of bird fatalities and found that the frequency of collisions is highest along façades that have lush exterior vegetation and either reflective or transparent windows (Gelb and Delacretaz 2009).

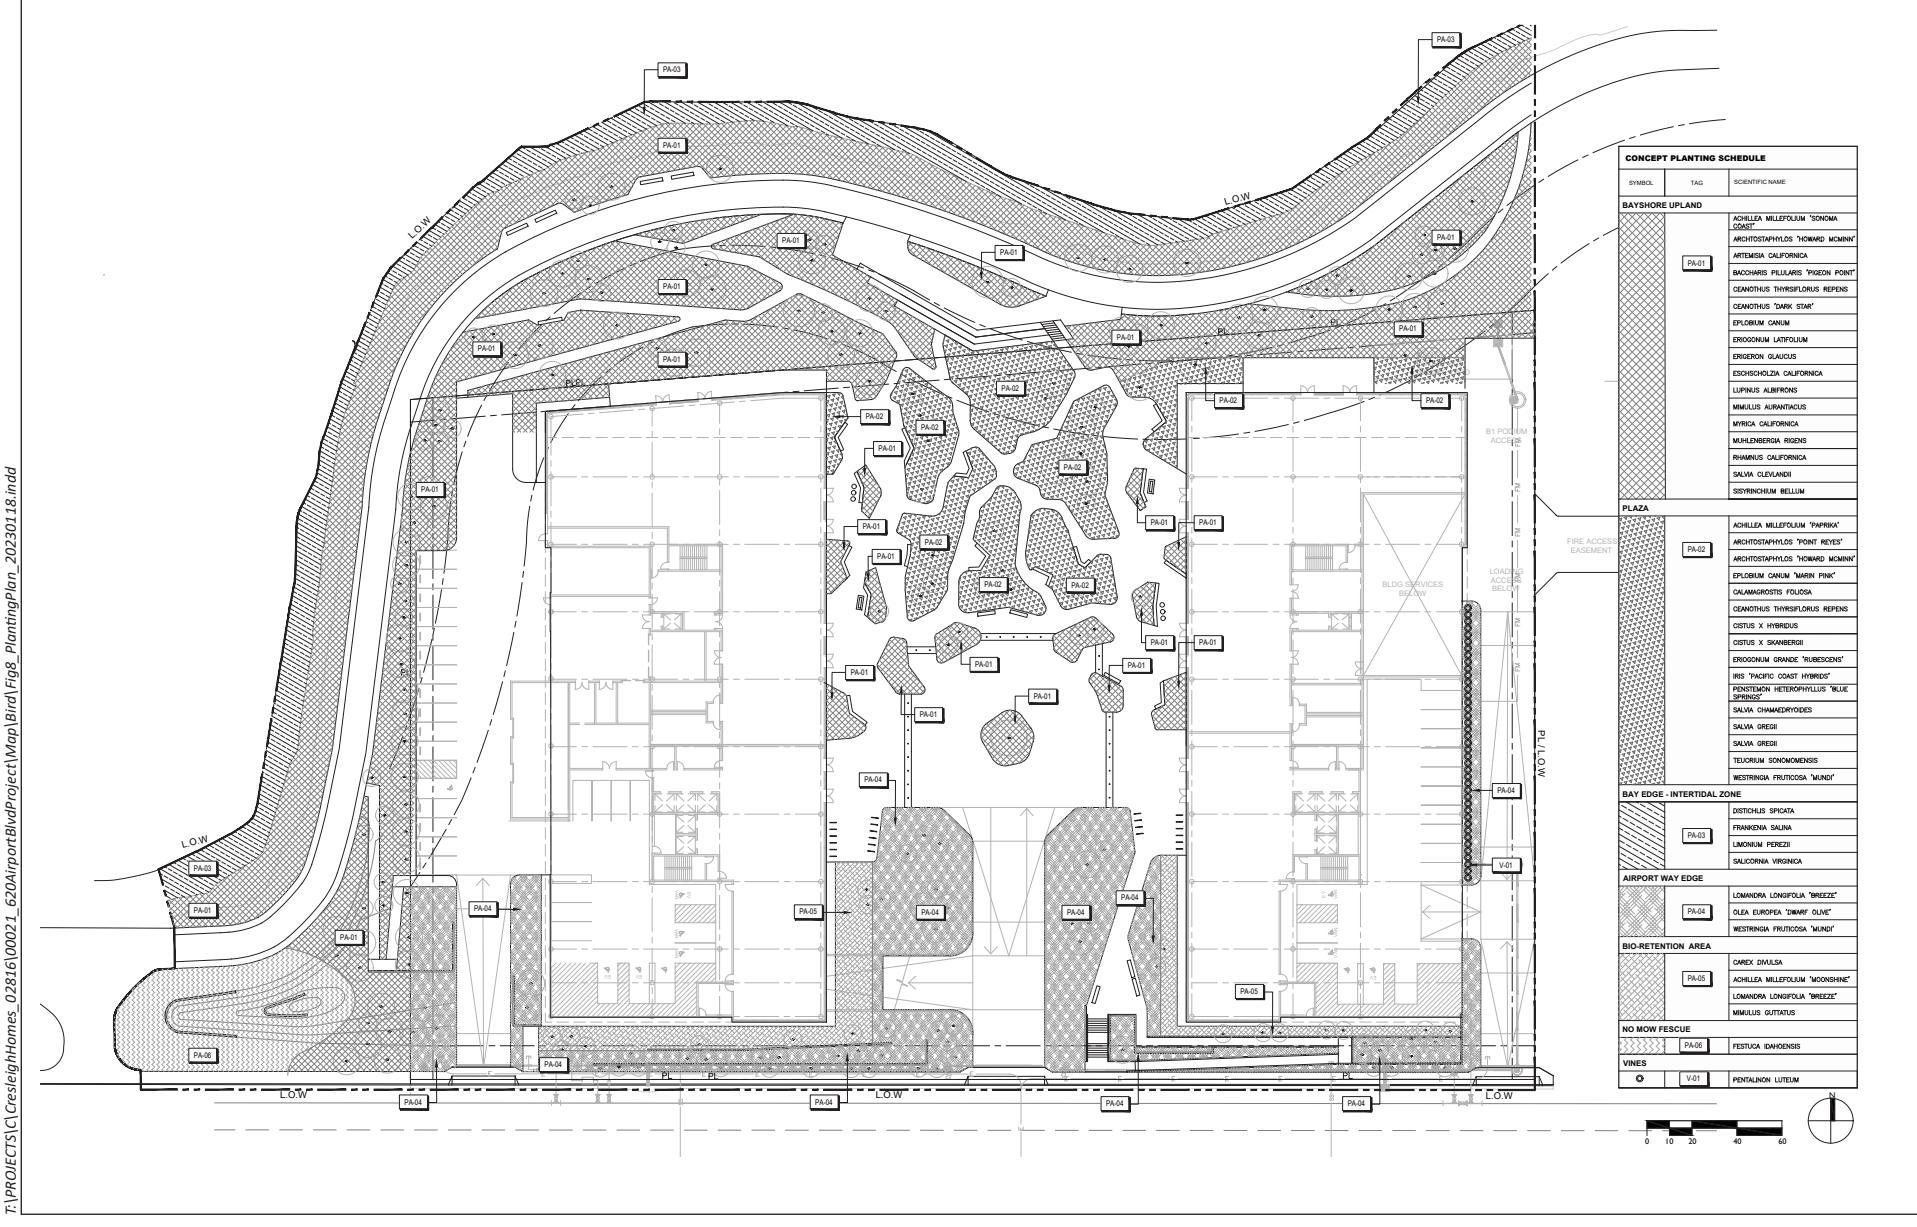
Planting Plan

The project proposes to remove existing vegetation and replace it with a mixture of California native, local native and nonnative tree, shrub, and herbaceous plant species, which will provide foraging, nesting and sheltering resources for birds (Appendix A, Figures 8 and 9). The existing vegetative cover is a similar mixture of native and nonnative vegetation which birds currently use; however, the project design incorporates a Bayshore Upland zone, and an intertidal zone in addition to native plantings in the plaza which will also incorporate nonnative plantings currently not found in the Study Area. The continuing presence and enhancement of these resources will provide ecological value for the site to migrant birds, wintering birds, year-round resident birds, and birds associated with shorelines compared to existing conditions. Based on the proposed extent of vegetation on the site, as well as the native vegetation and trees included in the planting plan, this vegetation is expected to provide higher quality habitat for both resident birds and migrating birds, compared to existing conditions. Thus, a moderate increase in the abundance of resident birds and a larger increase in the abundance of migrating birds is expected because of the proposed landscaping. Waterbirds are not expected to be attracted to the site's landscaping or to change in abundance or distribution as a result of the project.
